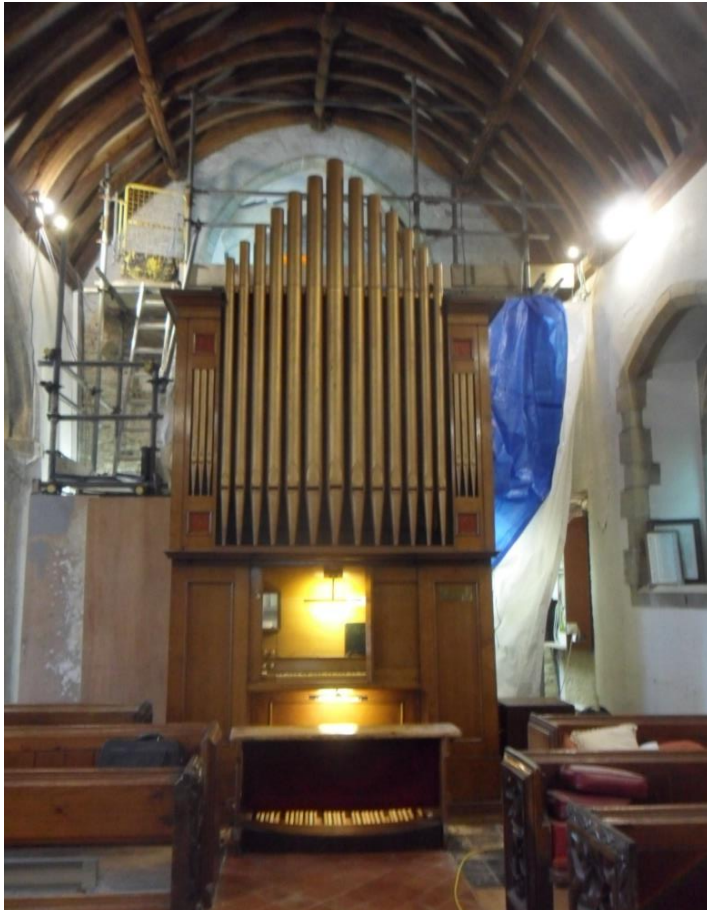
SCAFFOLD BEHIND THE ORGAN TO REPAIR THE ARCH AND REMOVE THE CEMENT RENDER

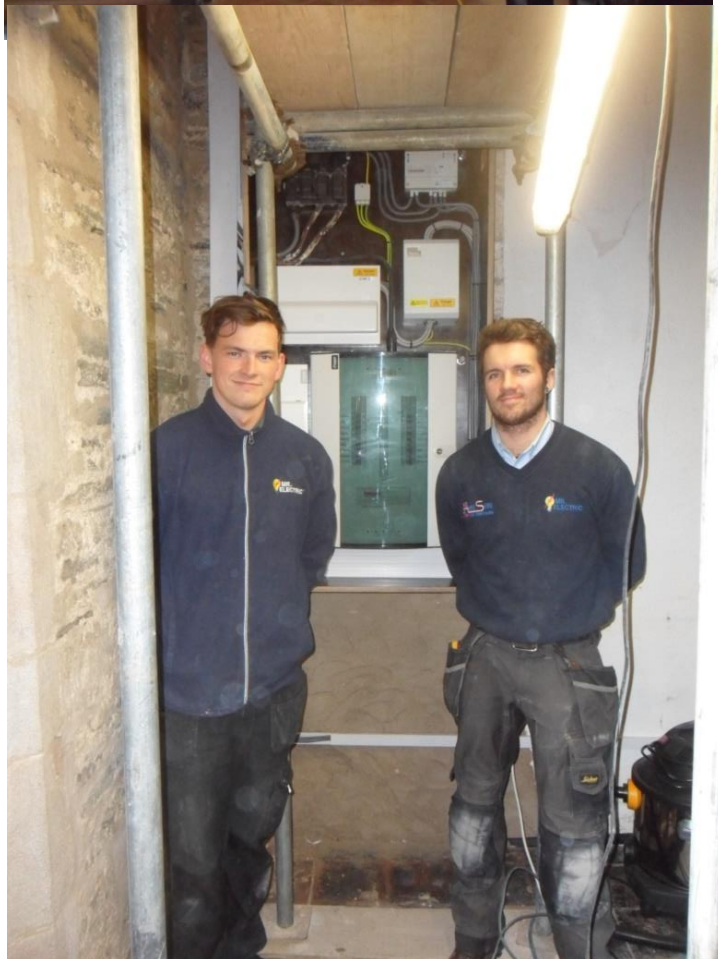
THE ELECTRICALS MOVED AND UPDATED THE ELECTRICAL PANEL FROM THE TOWER TO A NEW CUPBOARD AT THE WEST END OF THE NAVE

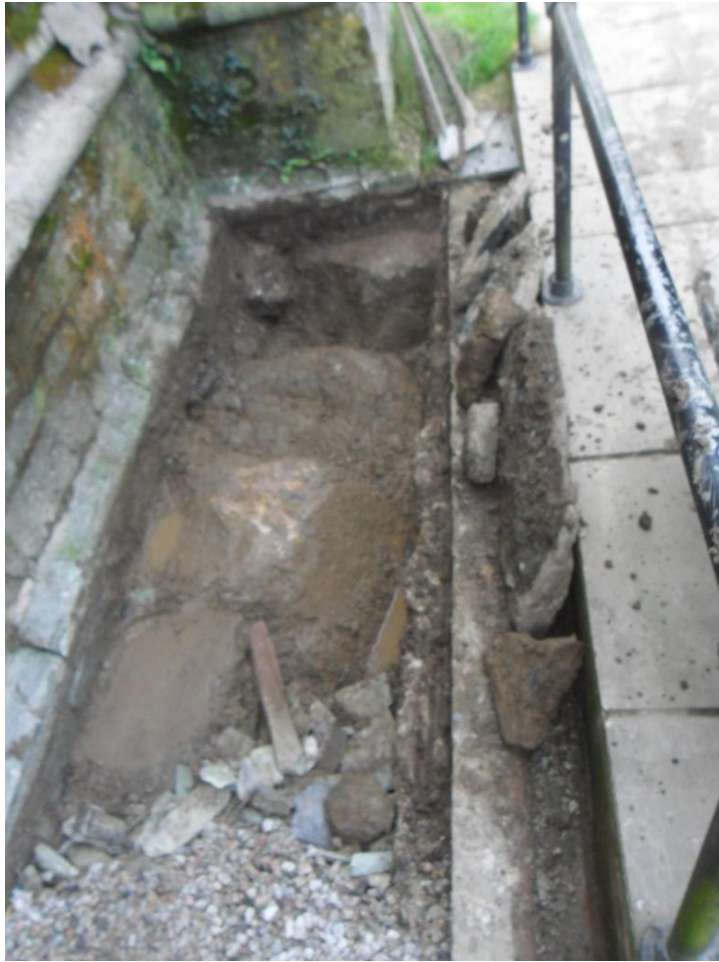
DIGGING THE NEW DRAINS TO THE NORTH AND SOUTH SIDE OF THE TOWER REVEALED THE BEDROCK ON WHICH THE TOWER WAS BUILT

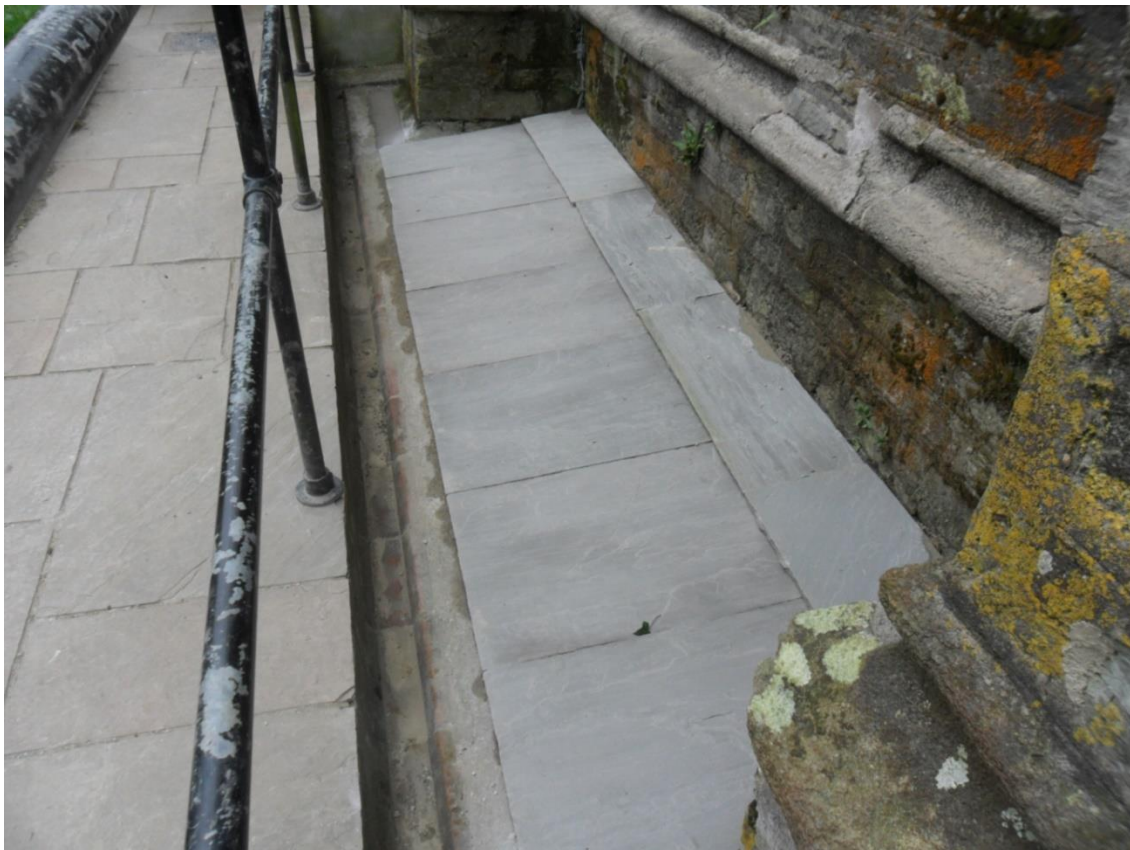
DRAINS NOW FILLED WITH GRAVEL & SURFACED WITH LIME STONE

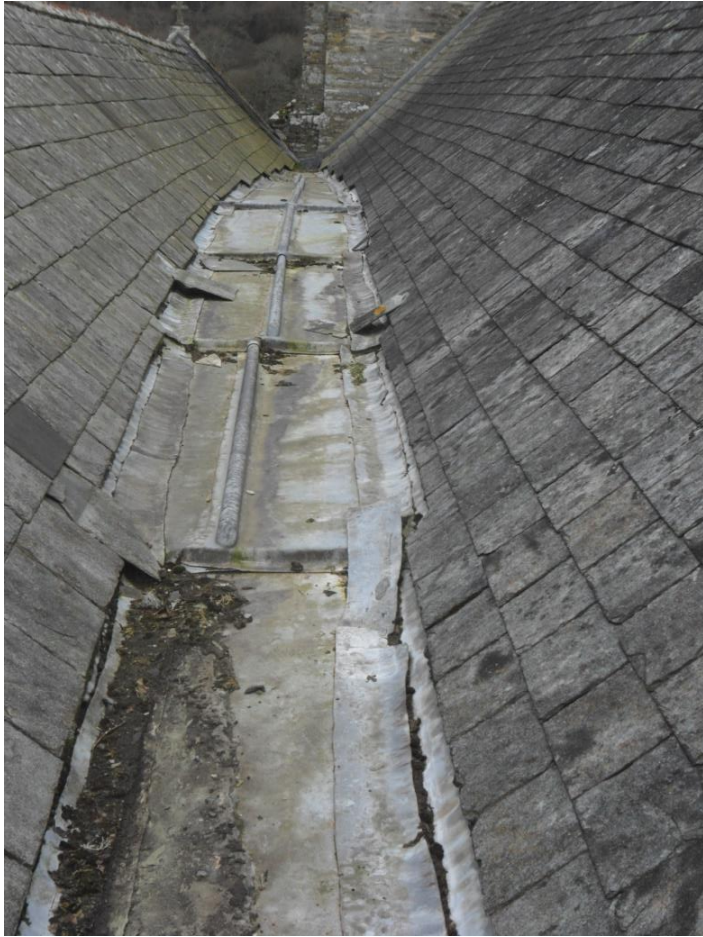
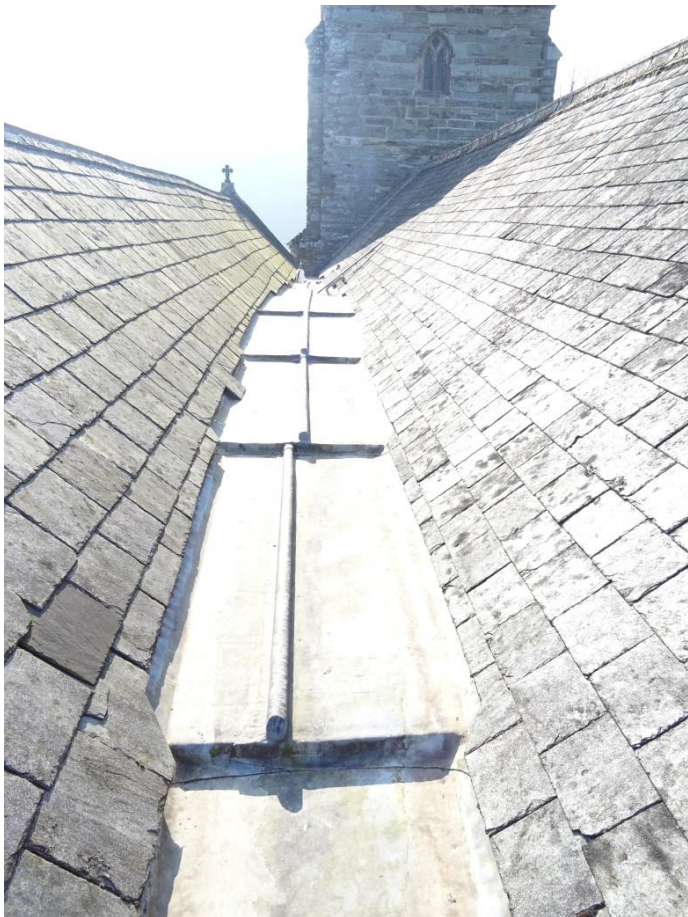
VALLEY GULLY BETWEEN NAVE AND
SOUTH AISLE ROOFS BEFORE AND
AFTER CLEANING

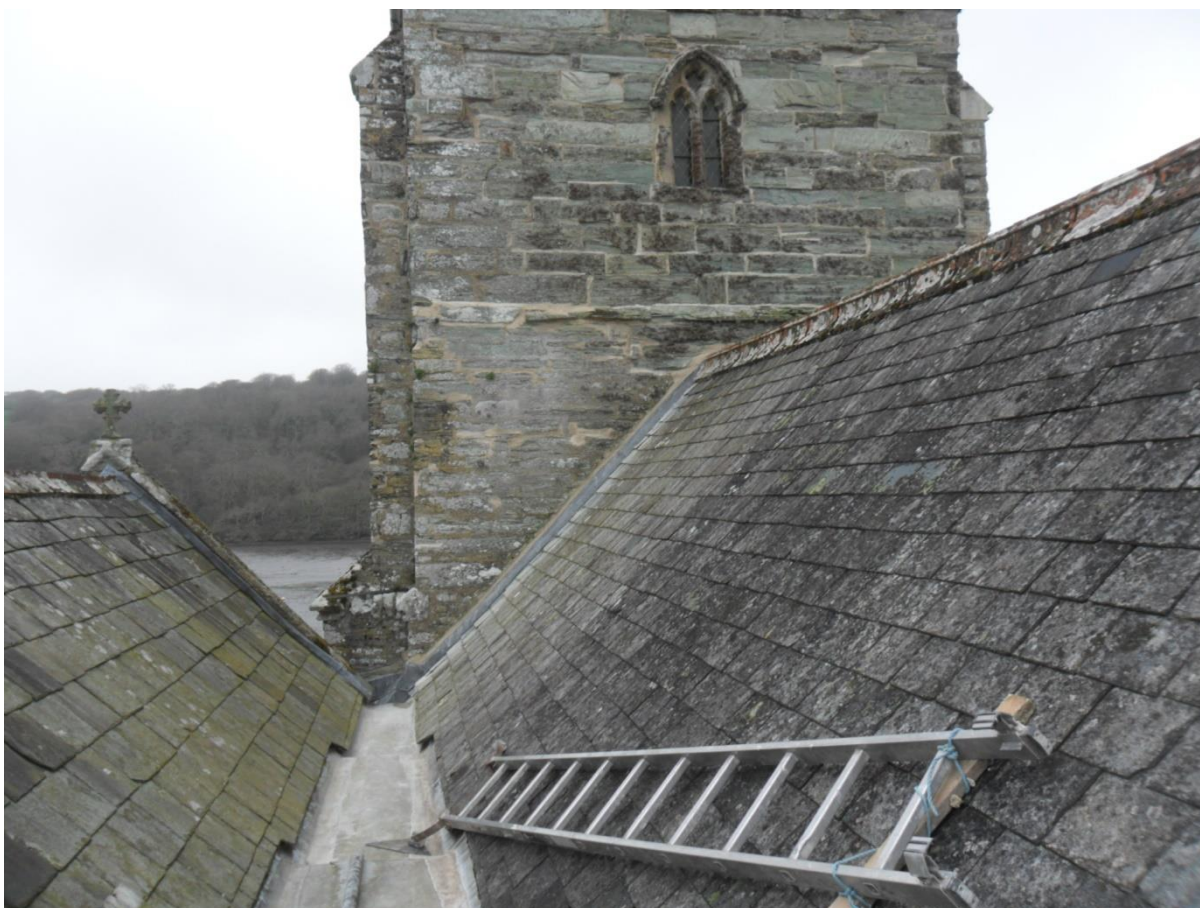
JUNCTION BETWEEN NAVE ROOF AND TOWER REPAIRED & LEAD RE-DRESSED

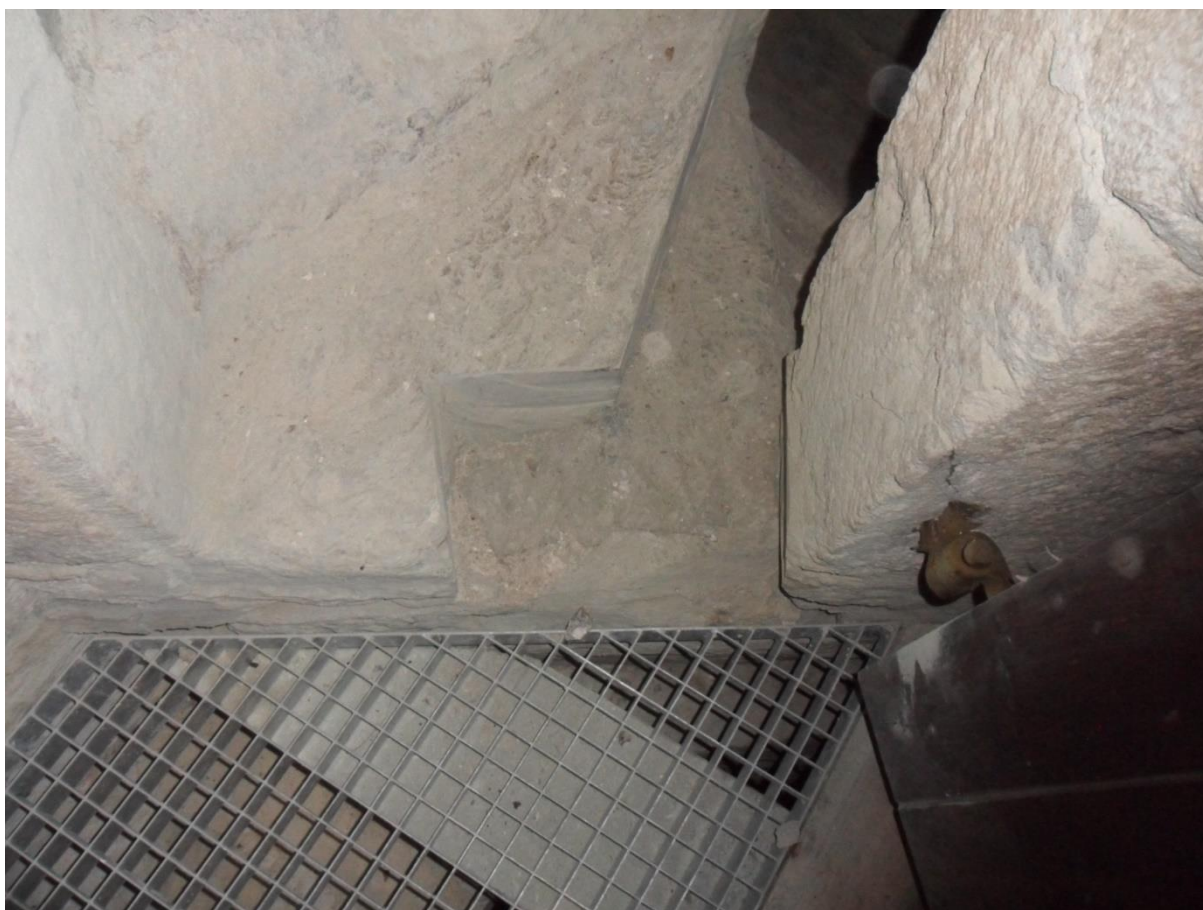
STEP TO OLD BELL CHAMBER FROM TOWER STAIR REPAIRED WITH NEW STONE

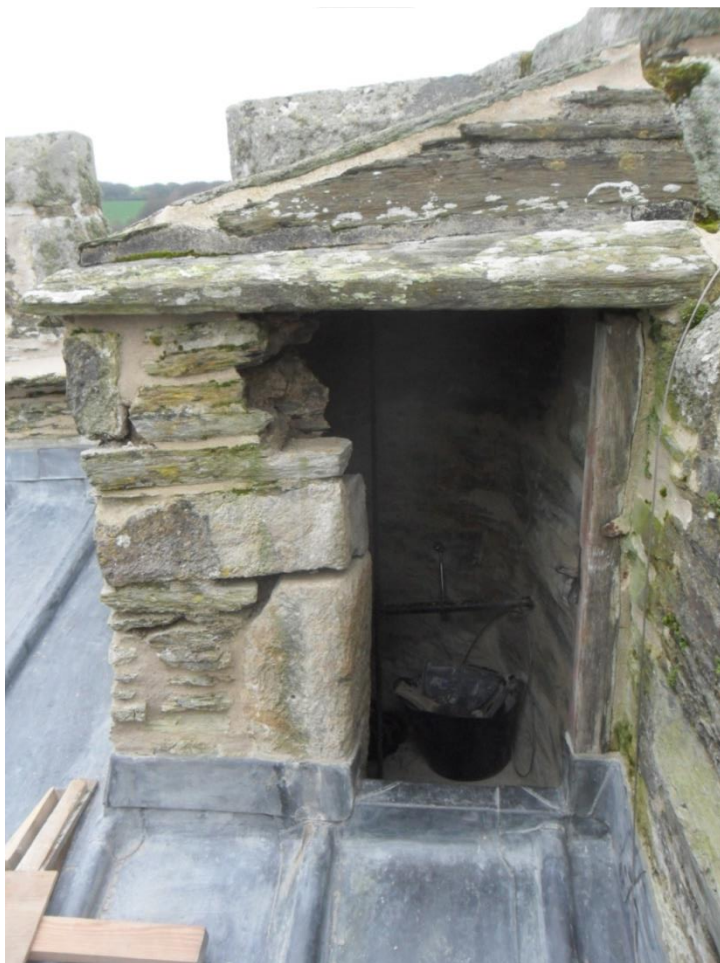
DOOR PINTLE DAMAGE

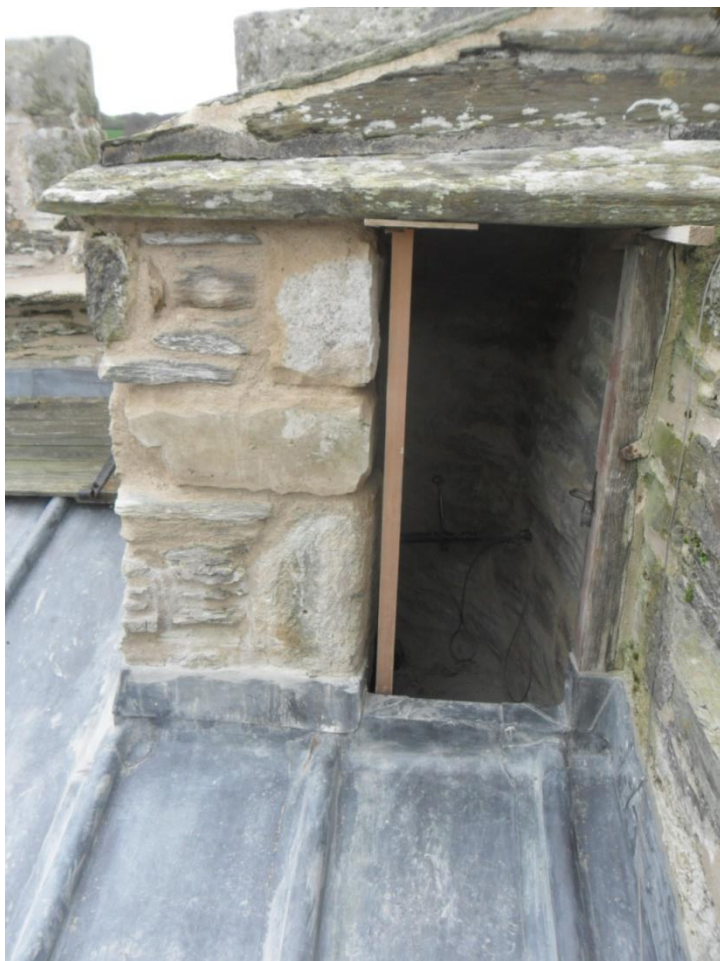
AFTER REPAIR

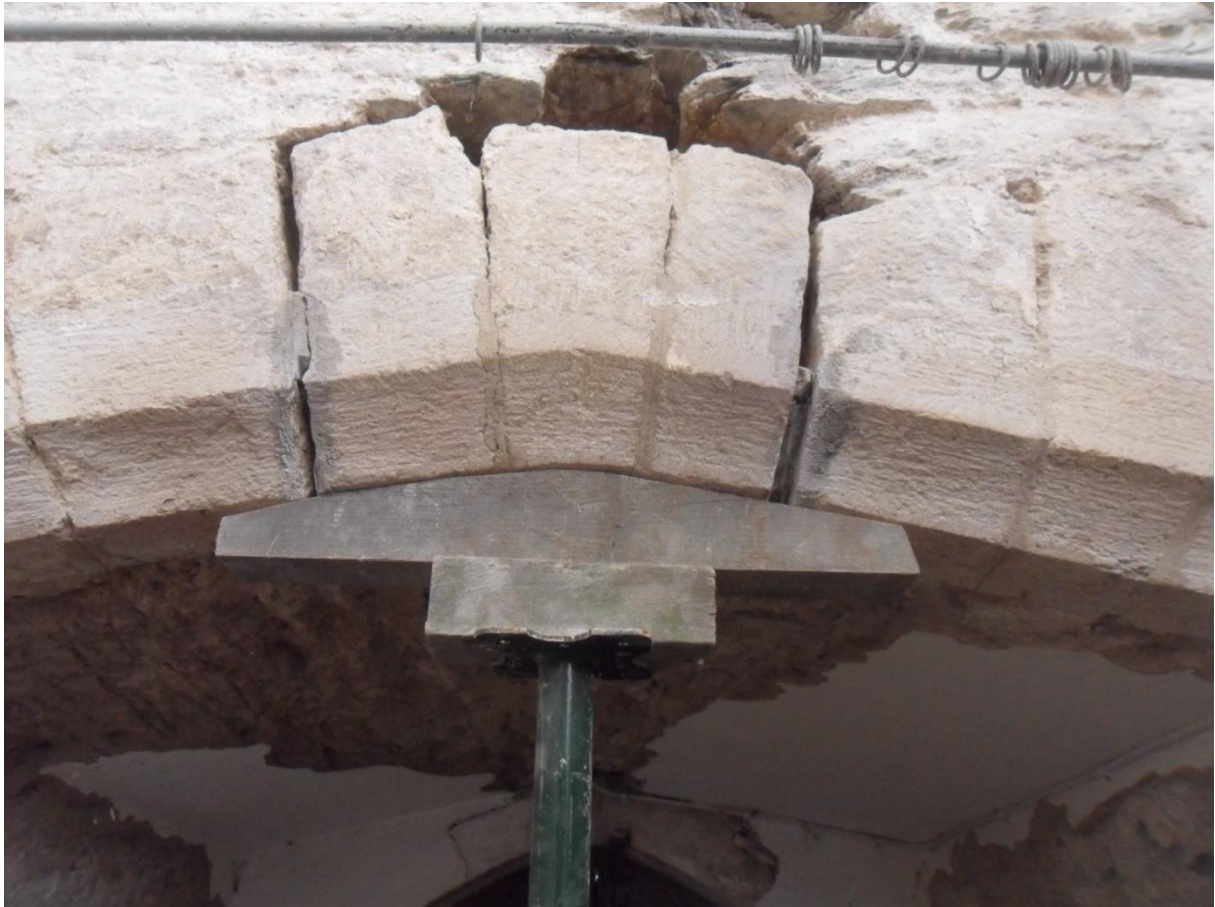
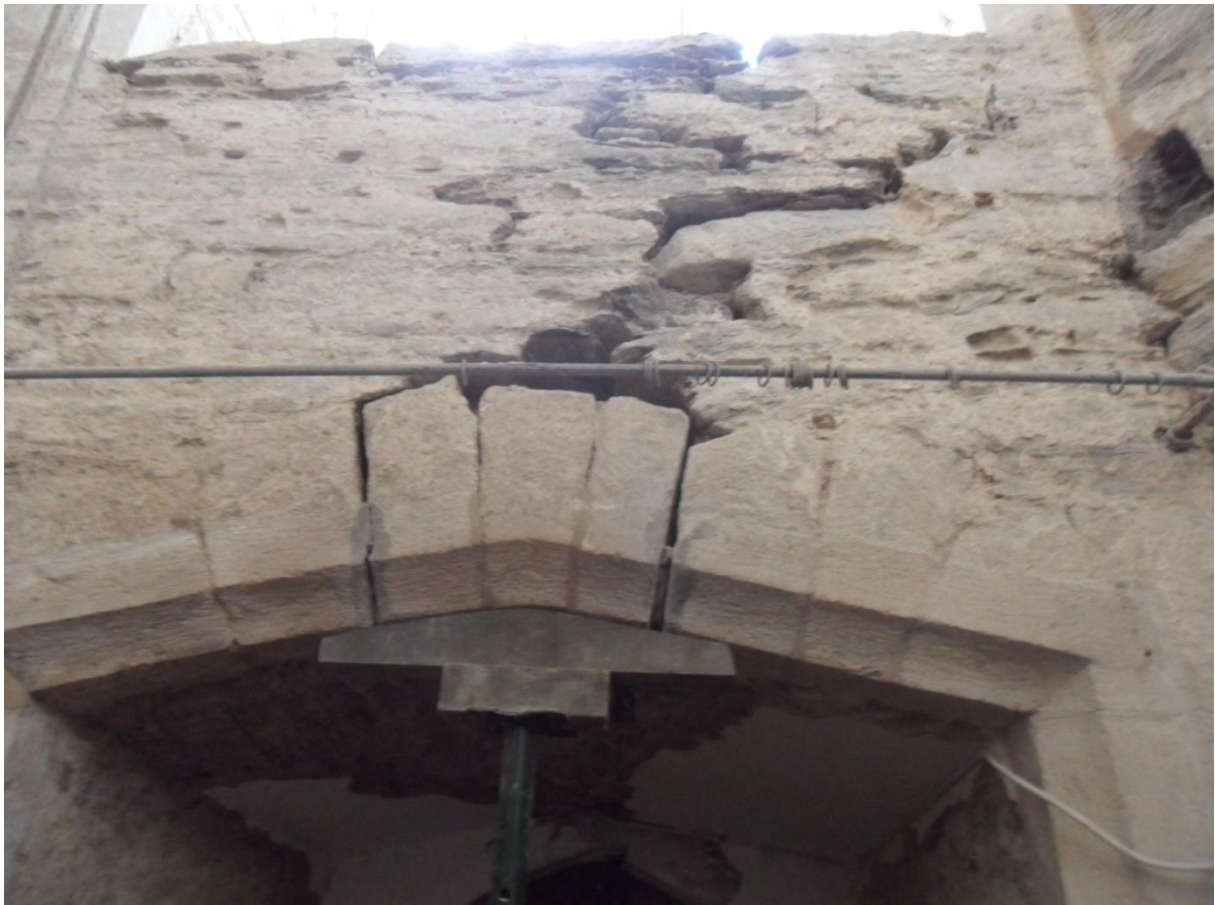
KEY STONES TO TOWER WEST DOOR ARCH HAD DROPPED

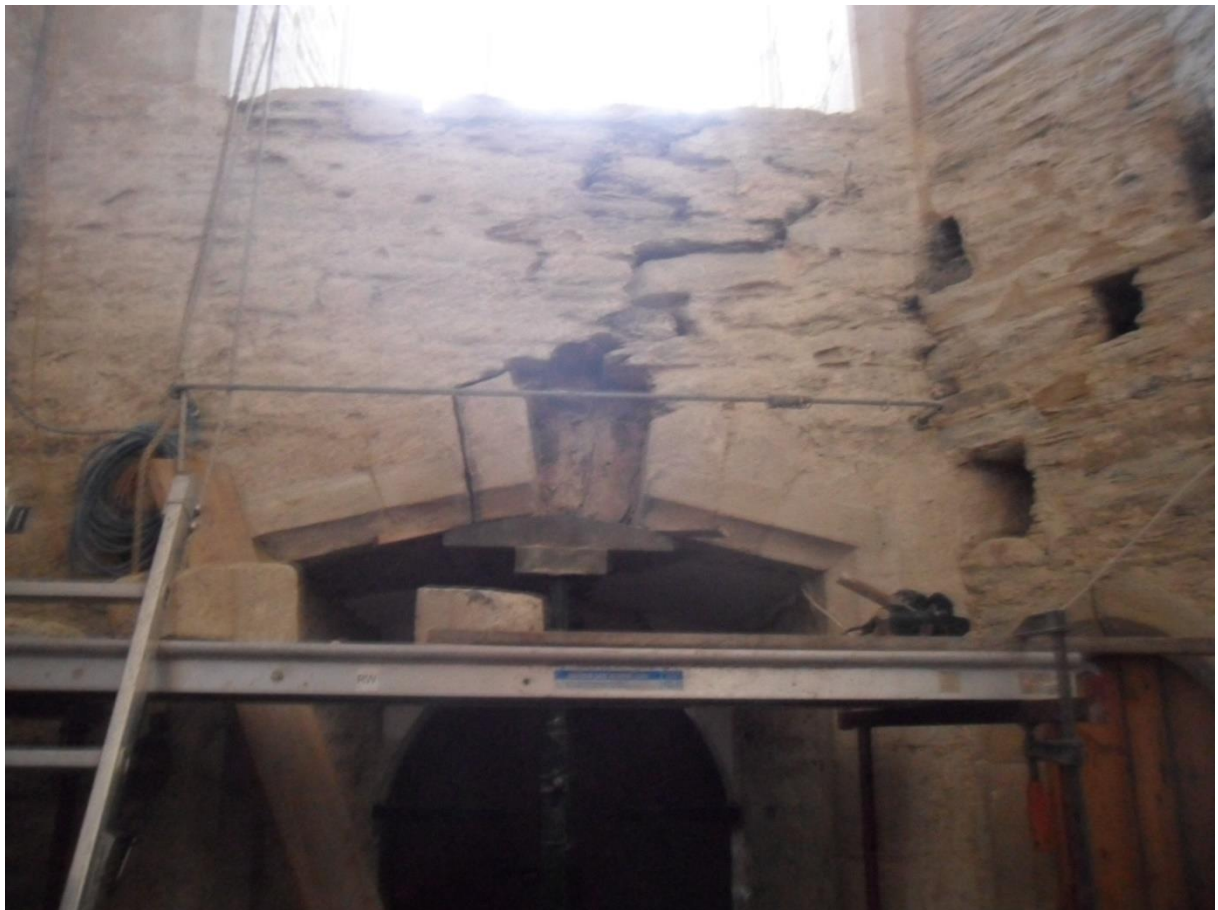
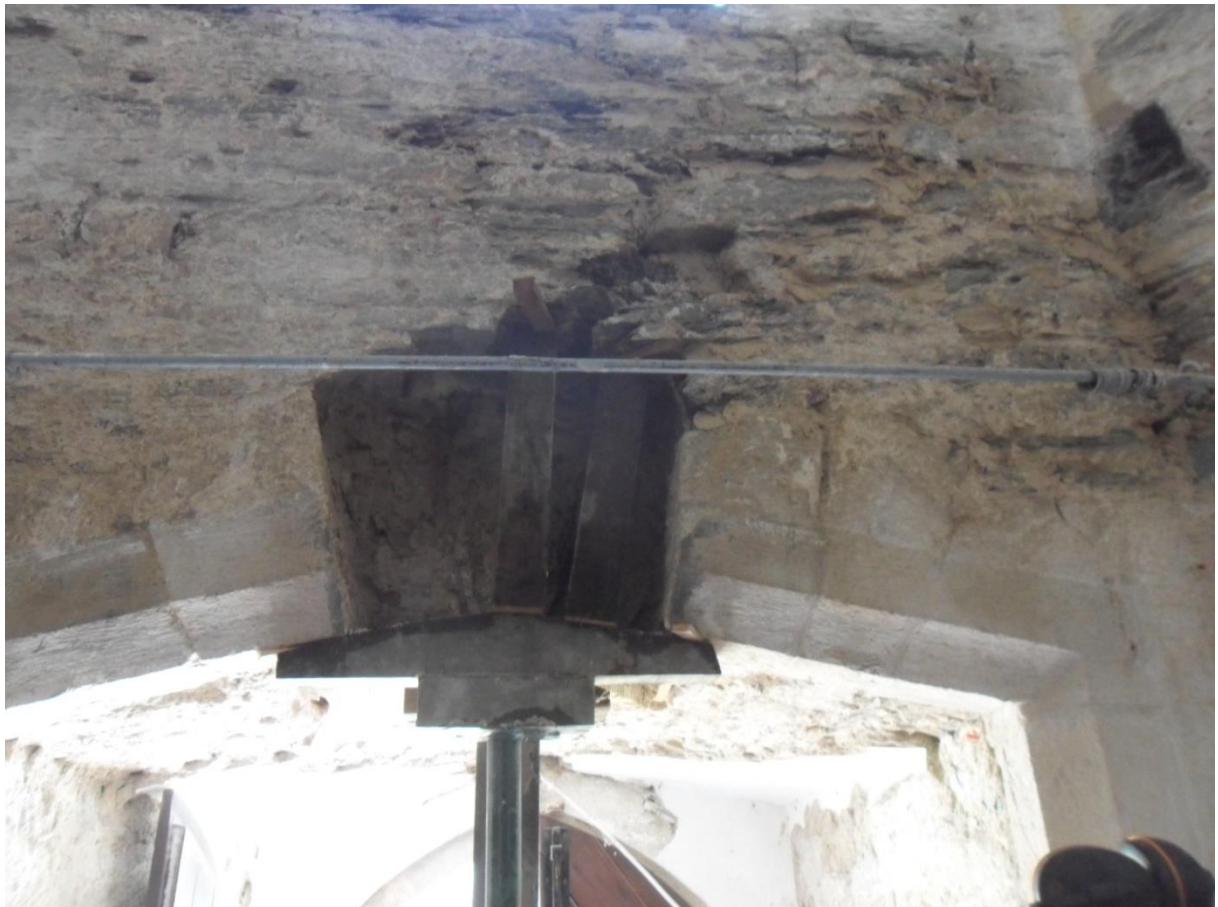
TOWER WEST DOOR ARCH DURING REPAIR

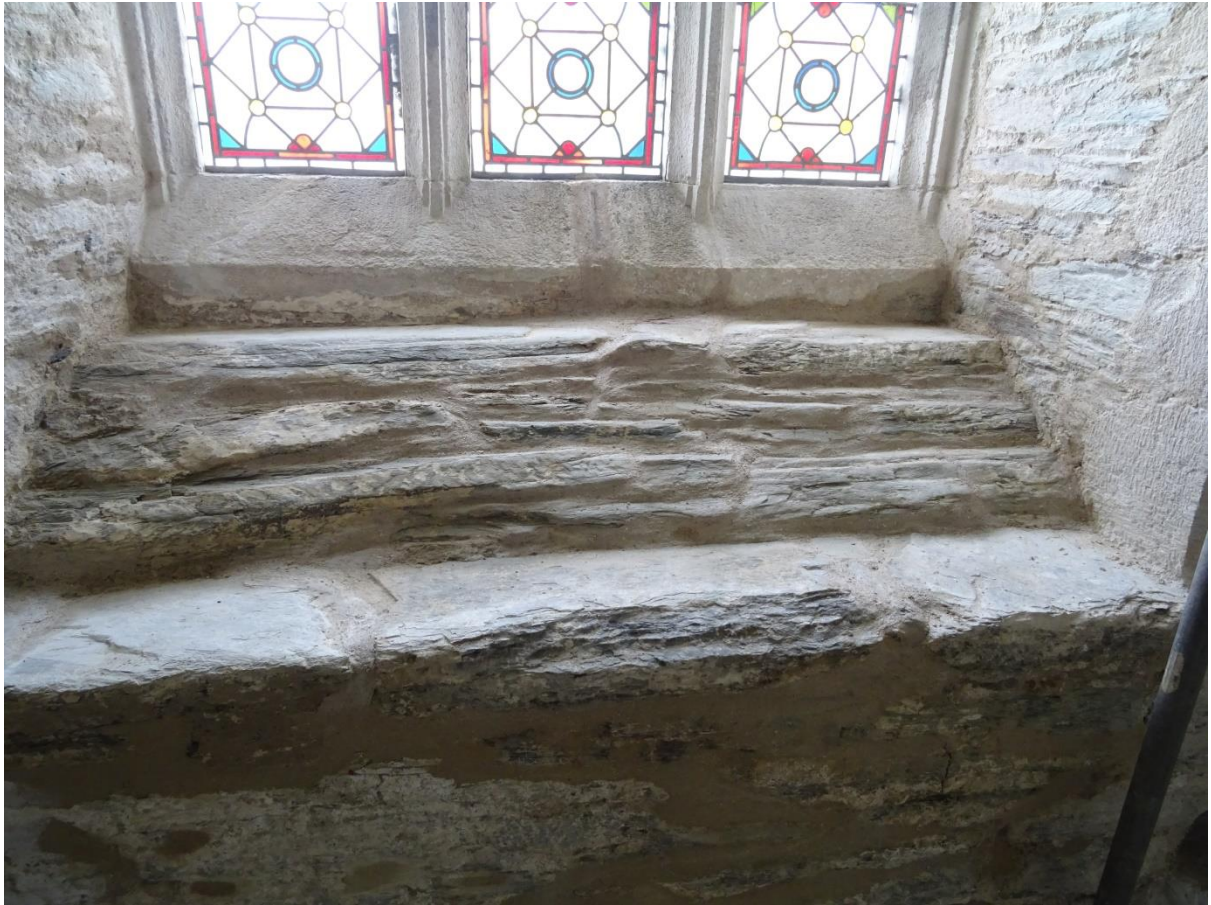
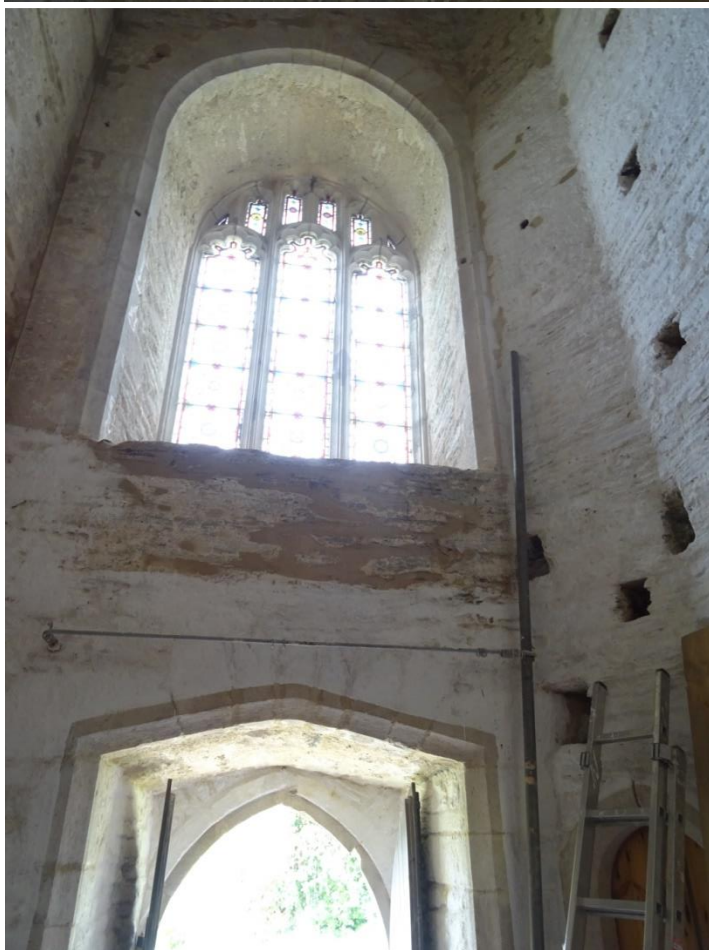
SILL & ARCH AFTER REPAIR

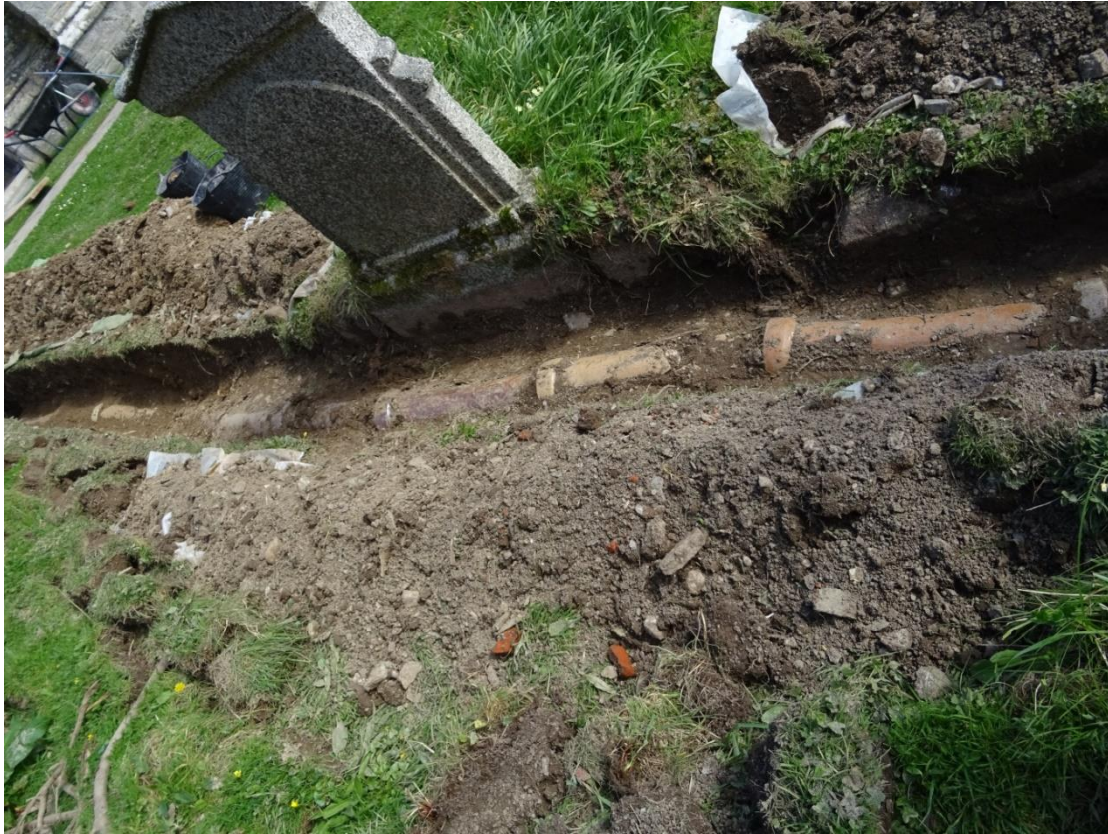
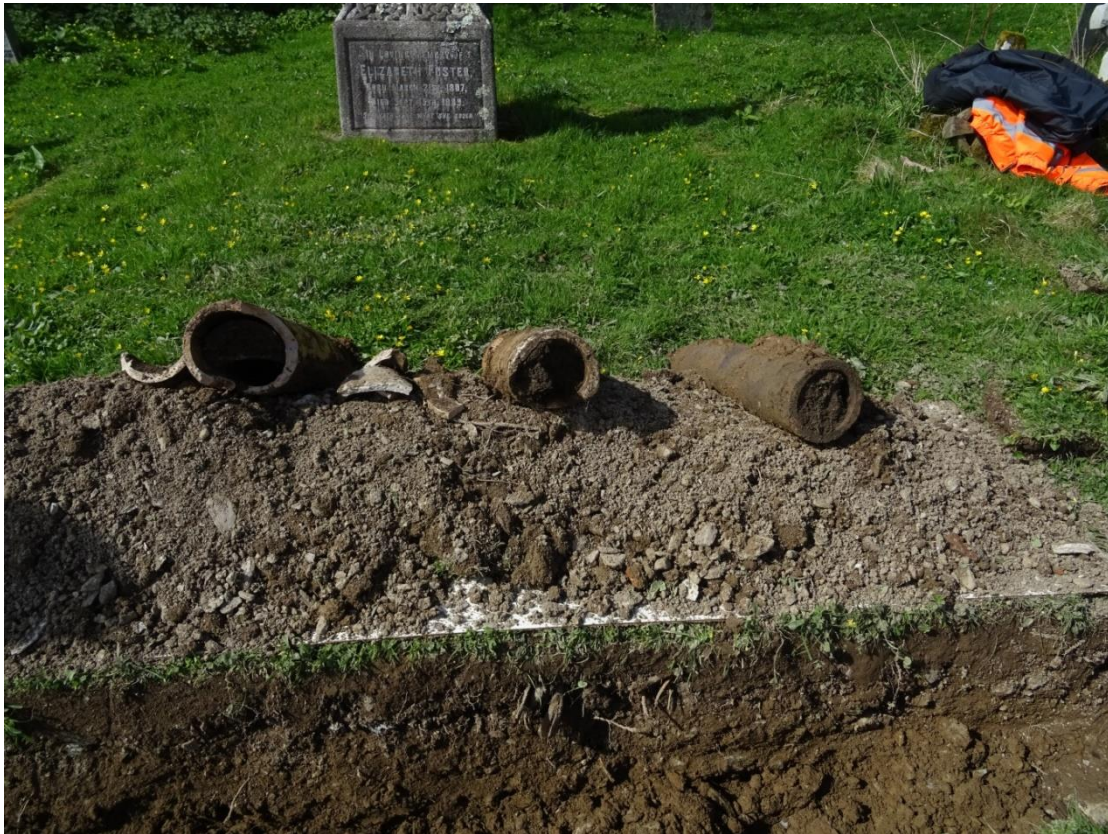
RAINWATER DRAINE FROM TOWER – BLOCKED AND BROKEN CLAY PIPES
SETTLED TO IN AN UNEVEN FALL
