PEARSON LUBBOCK ARCHITECTS
BELL CHAMBER OPENINGS BEFORE AND AFTER FIRST PHASE

ST WINNOW CHURCH TOWER FIRST PHASE

5TH OCTOBER 2016

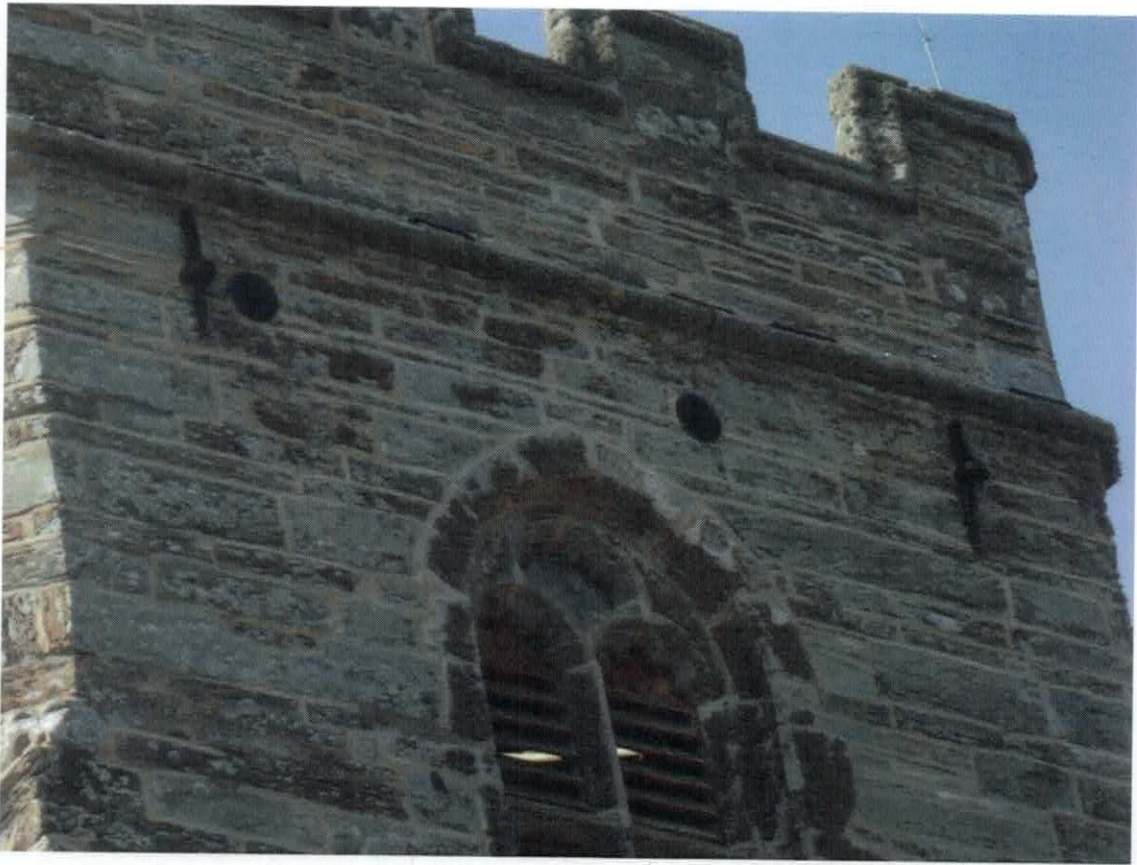
EAST BELL CHAMBER WALL EXTERNAL VIEW

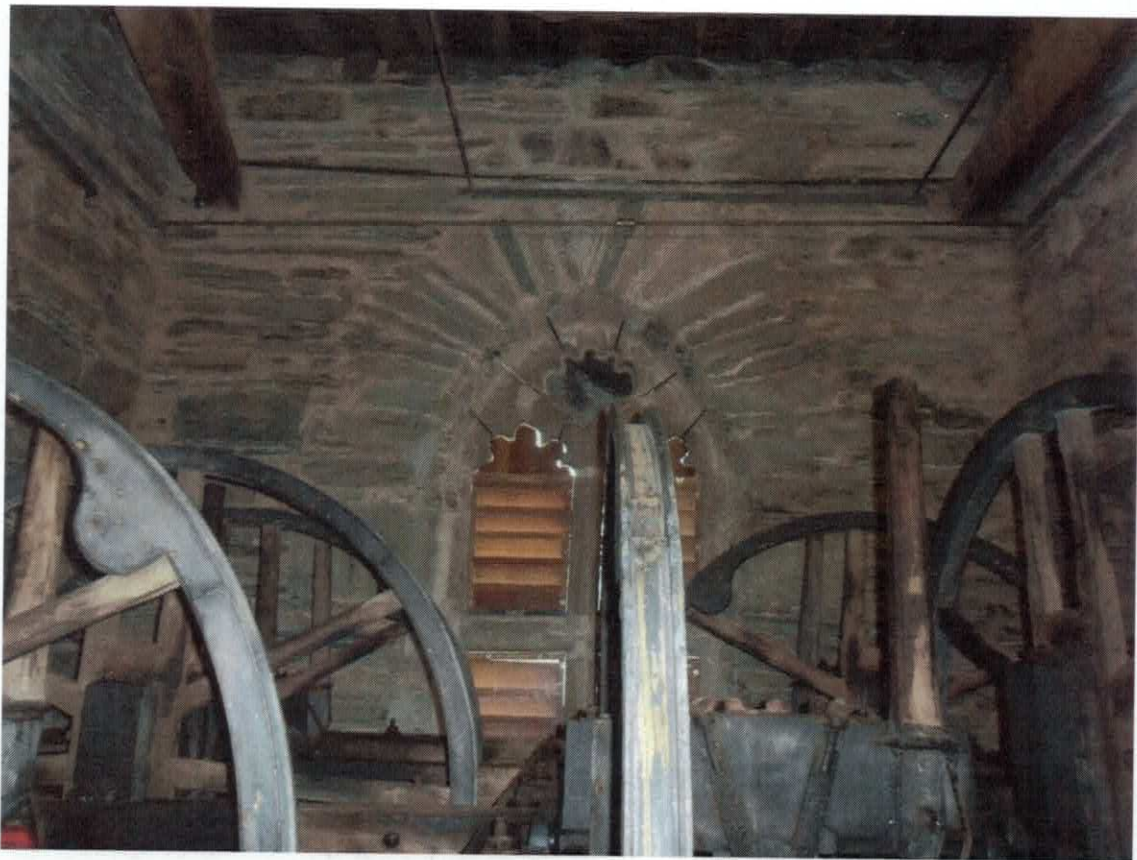
EAST BELL CHAMBER WALL INTERNAL VIEW

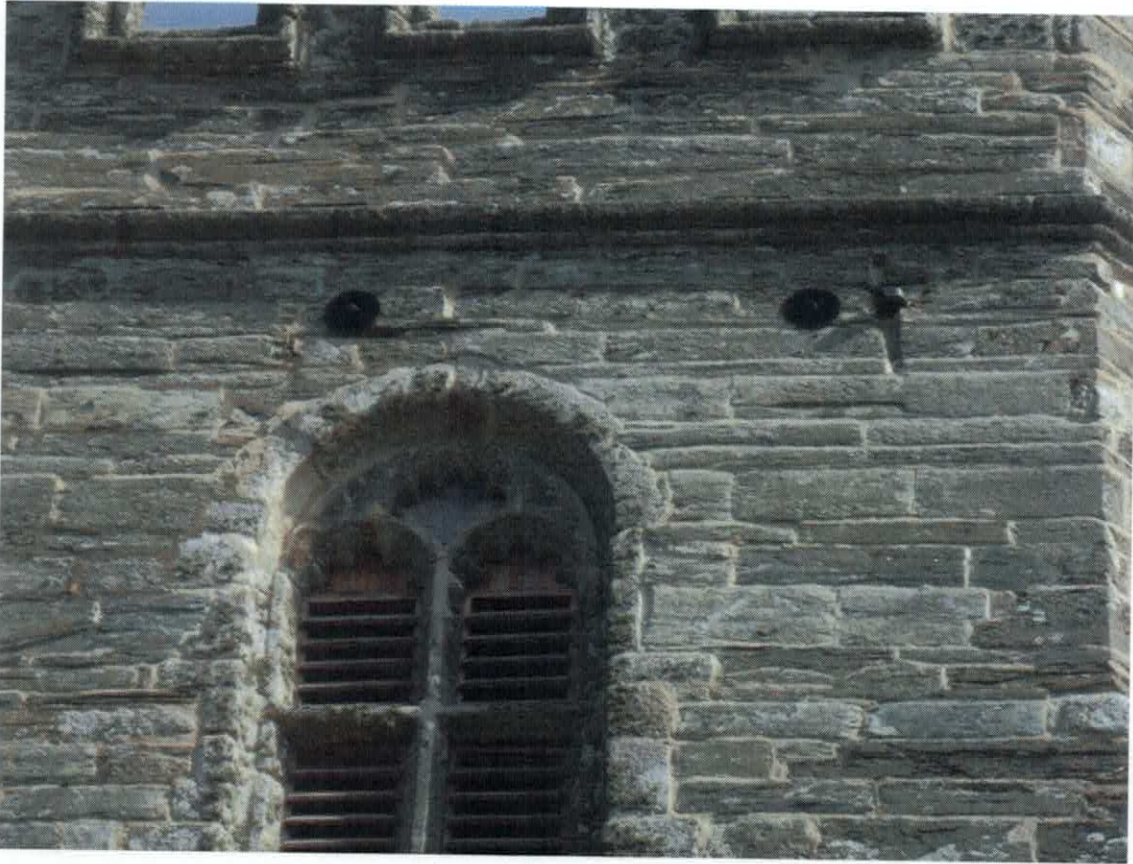
WEST BELL CHAMBER WALL EXTERNAL VIEW

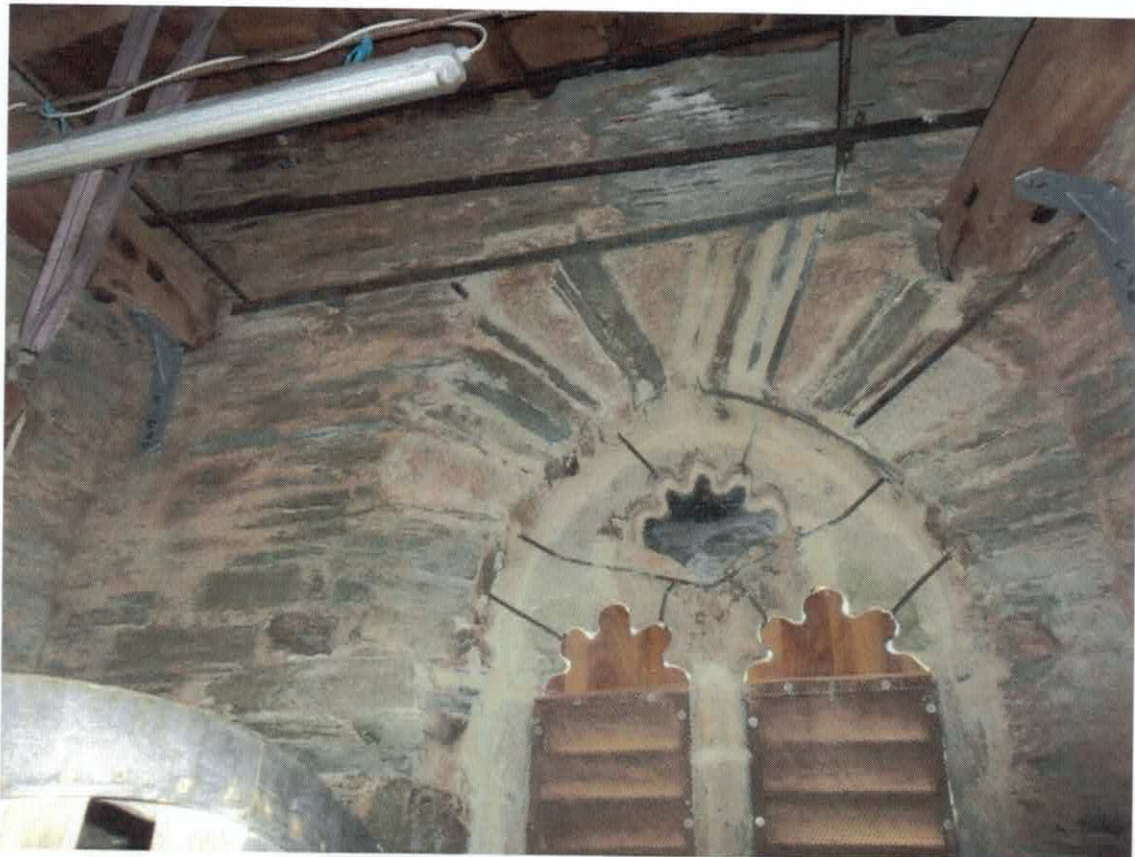
WEST BELL CHAMBER WALL INTERNAL VIEW

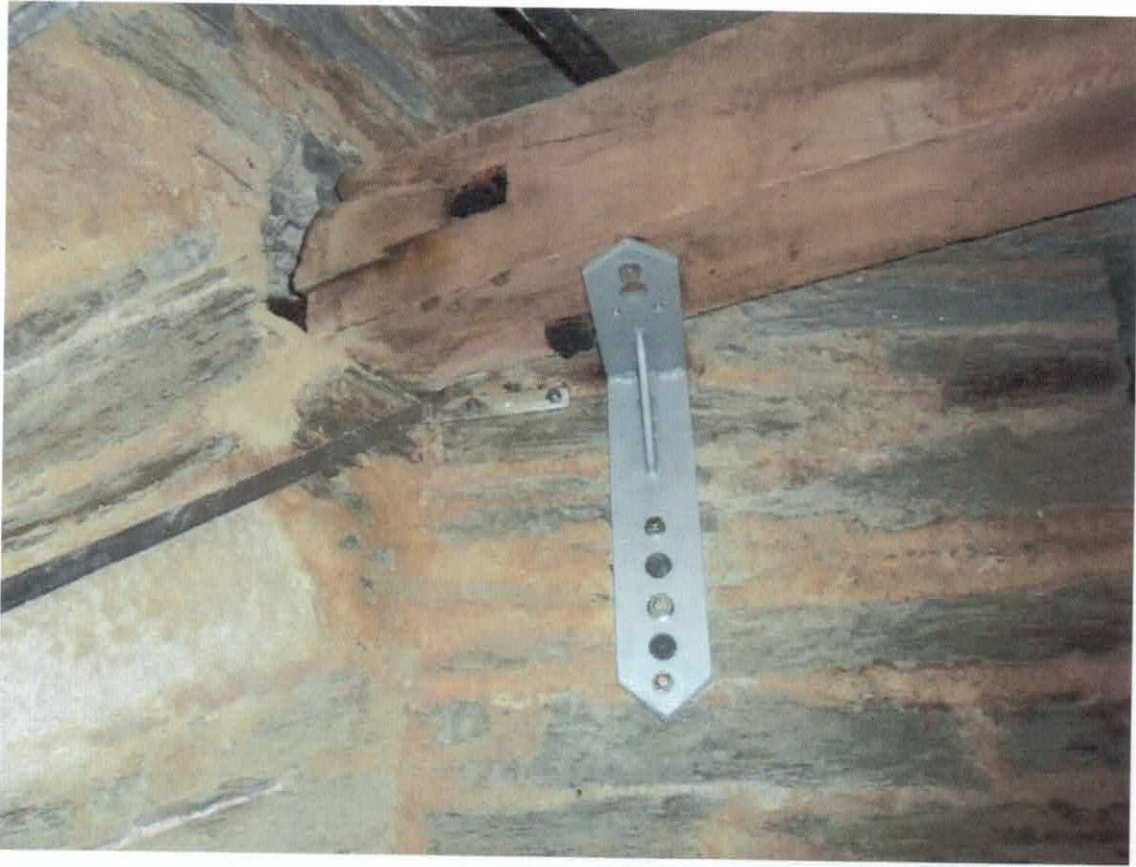
NEW BRACKET TO WEST END OF NORTHERN TIE BEAM

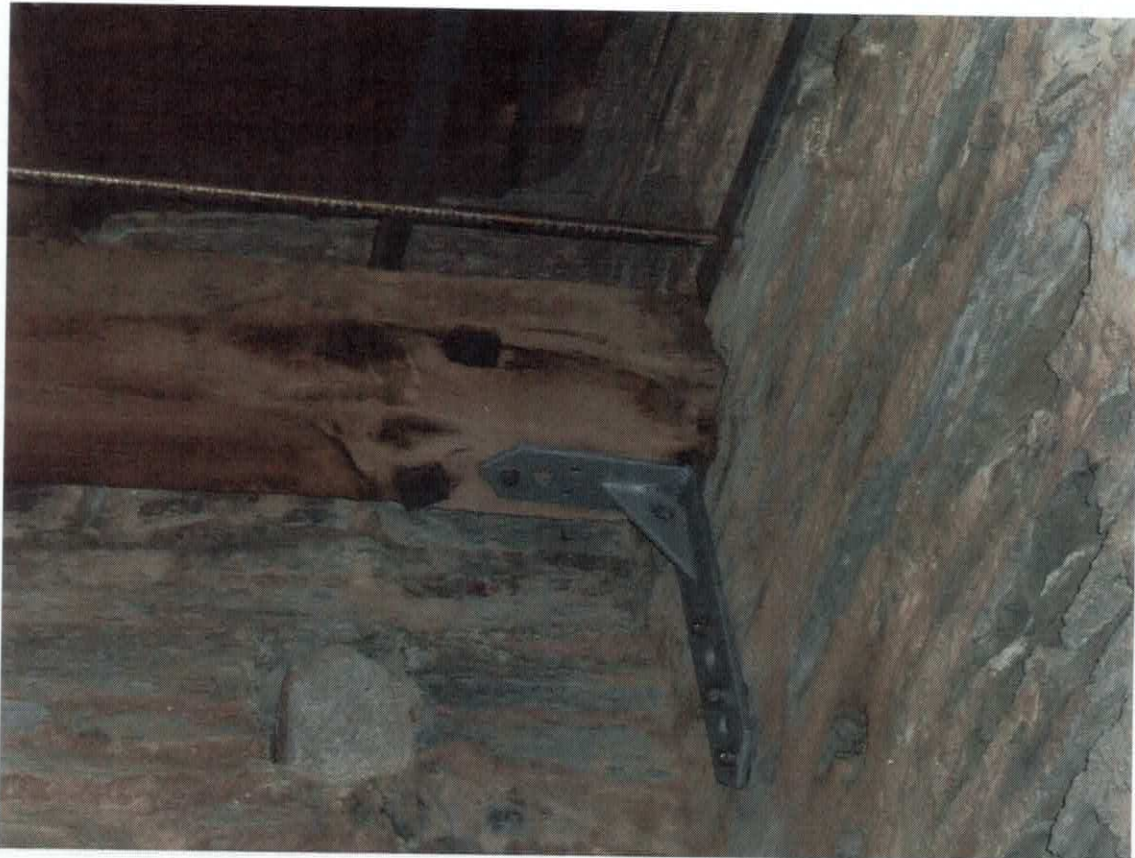
NEW BRACKET TO WEST END OF SOUTHERN TIE BEAM

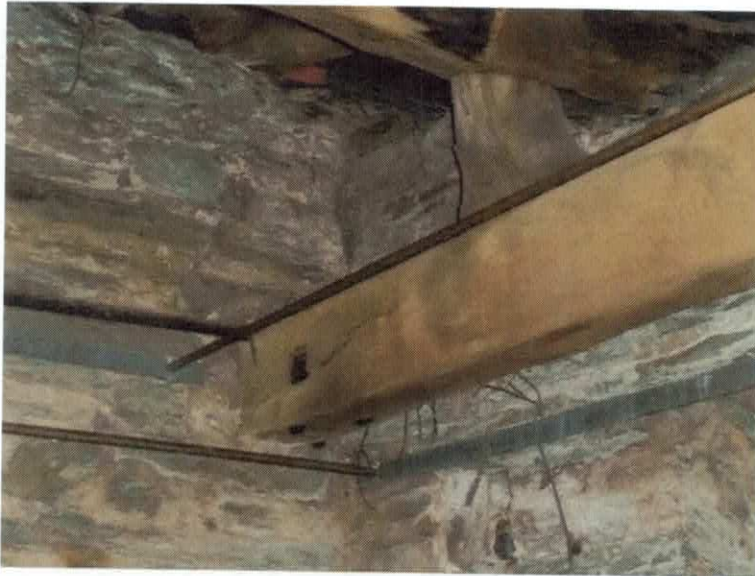
OLD ROTTEN BLOCK (SECTION OF TREE TRUNK) TO EAST END OF SOUTHERN TIE BEAM.

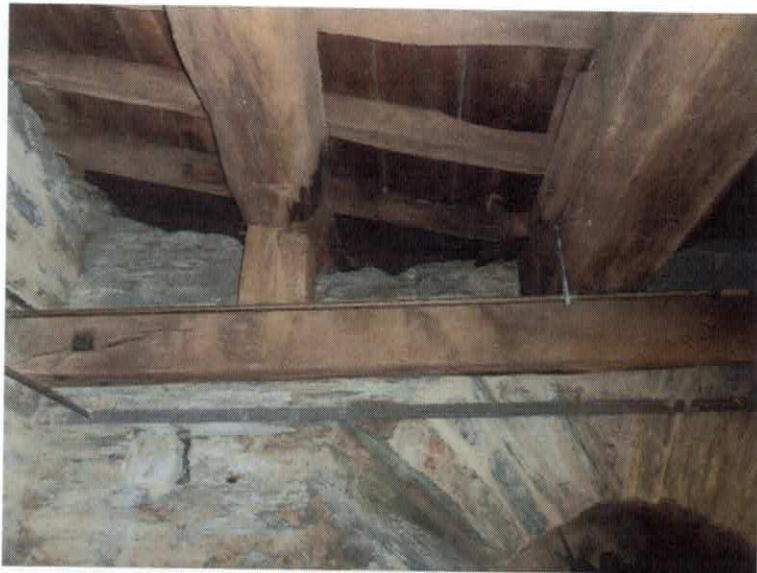
NEW OAK BLOCK, MADE TO FULLY SUPPORT THE EASTERN ROOF BEAM FROM THE EAST END OF THE SOUTHERN TIE BEAM.

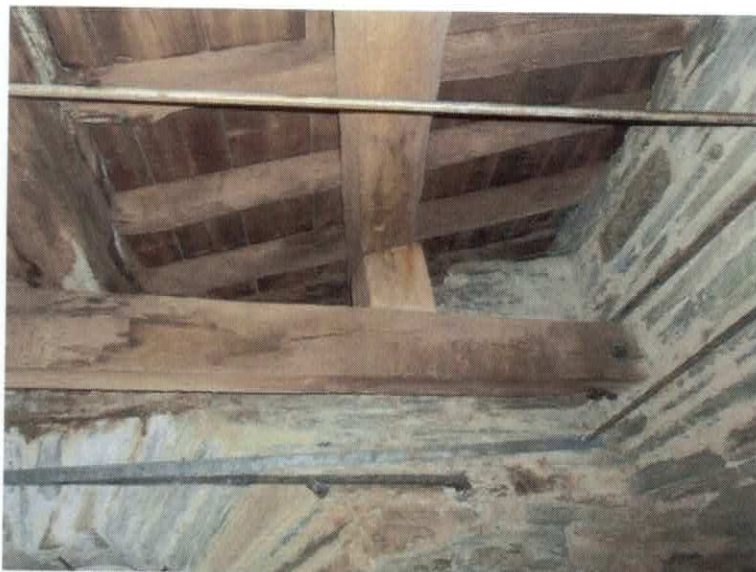
NEW OAK BLOCK MADE TO SUPPORT THE NORTHERN END OF THE EASTERN ROOF BEAM FROM THE EAST END OF THE NORTHERN TIE BEAM. THERE WAS NO BLOCK HERE BEFORE WORKS STARTED. THE YEAR 2016 HAS BEEN CARVED INTO THE SOUTHERN SIDE OF THIS BLOCK.

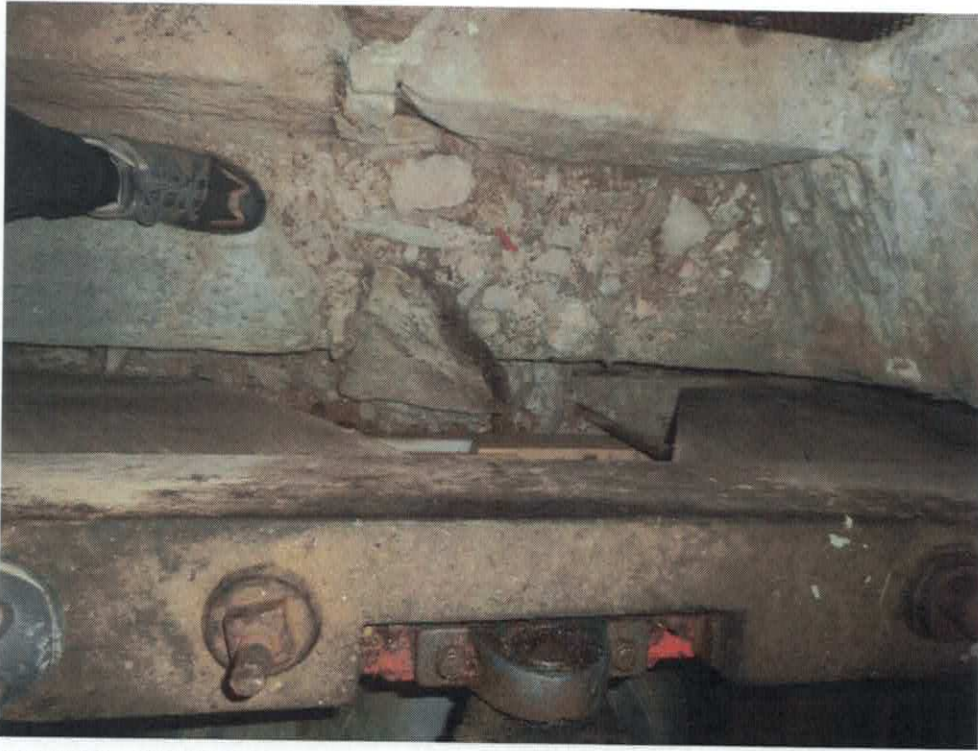
SOUTH BELL CHAMBER WINDOW LEDGE BEFORE FIRST PHASE

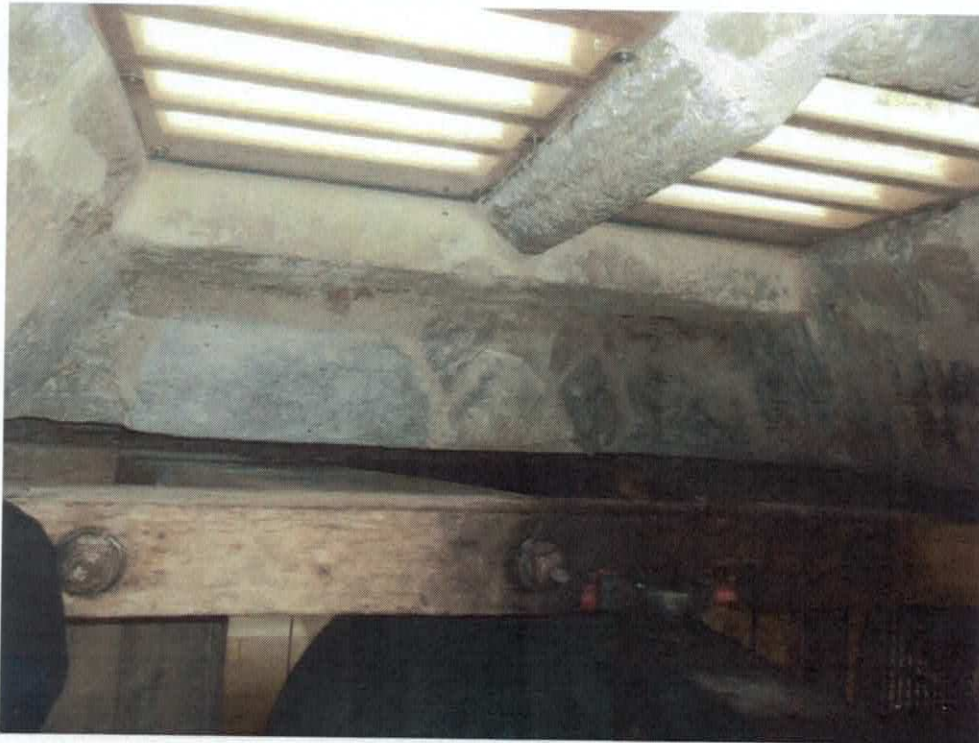
SOUTH BELL CHAMBER WINDOW LEDGE AFTER RUBBLE REMOVAL AND CLEANING DURING FIRST PHASE – 6 WHEELBARROW LOADS OF RUBBLE, DUST AND BIRDS NESTS WERE REMOVED FROM THE BELL CHAMBER, LARGELY FROM AROUND THE EDGES OF THE BELL FRAME BUT ALSO FROM THE TOPS OF THE WALLS

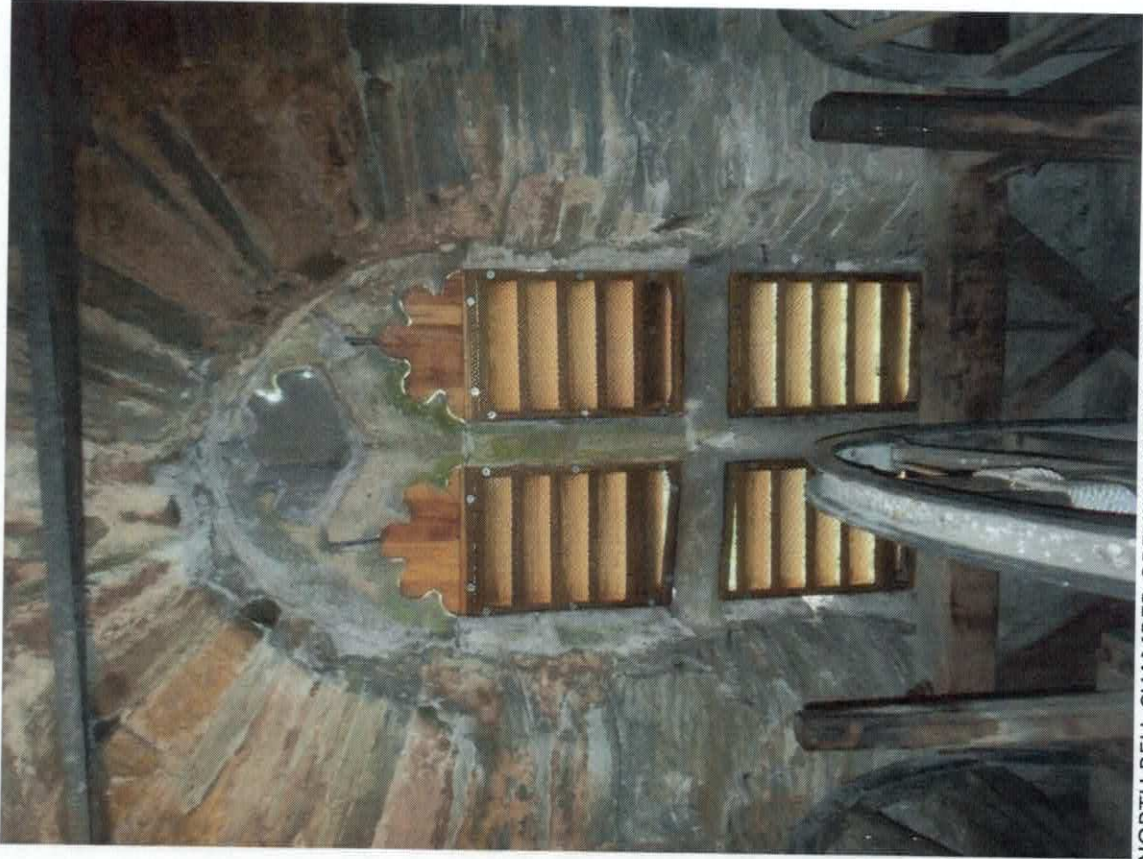
NORTH BELL CHAMBER OPENING BEFORE REPAIR

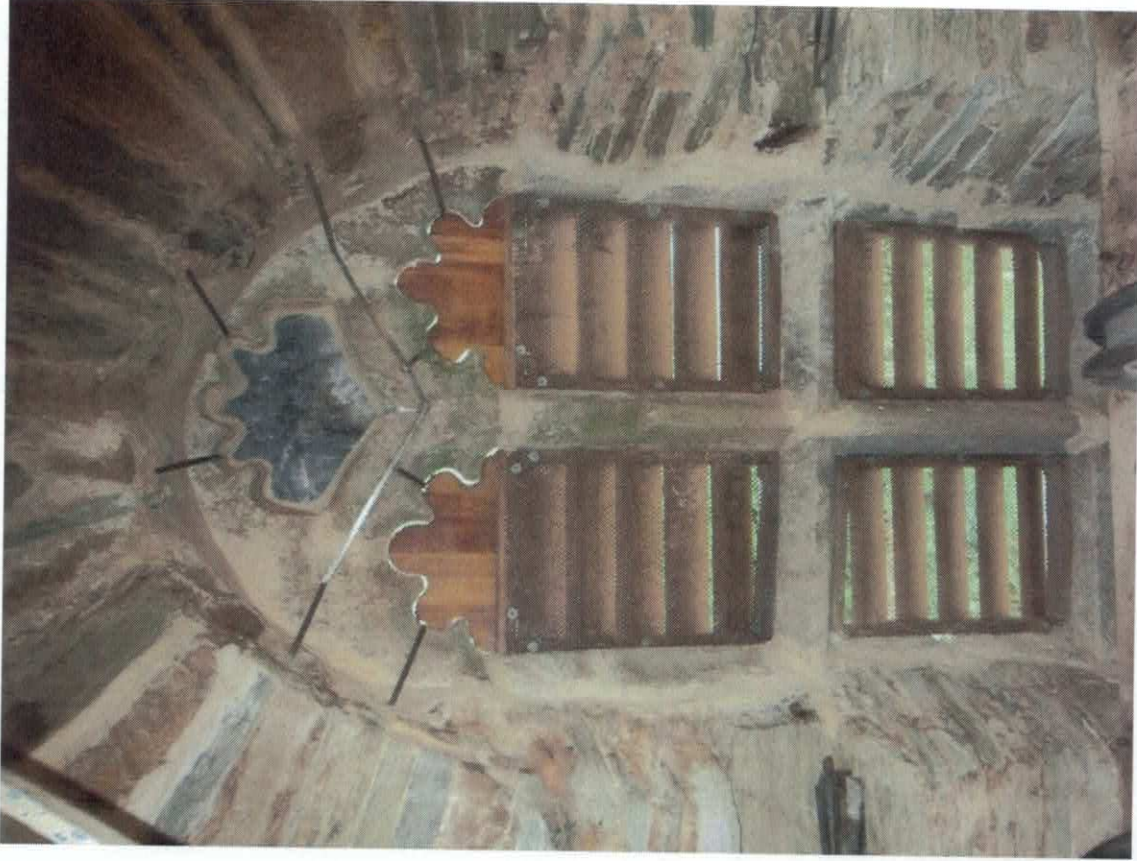
NORTH BELL CHAMBER OPENING AFTER REPAIR

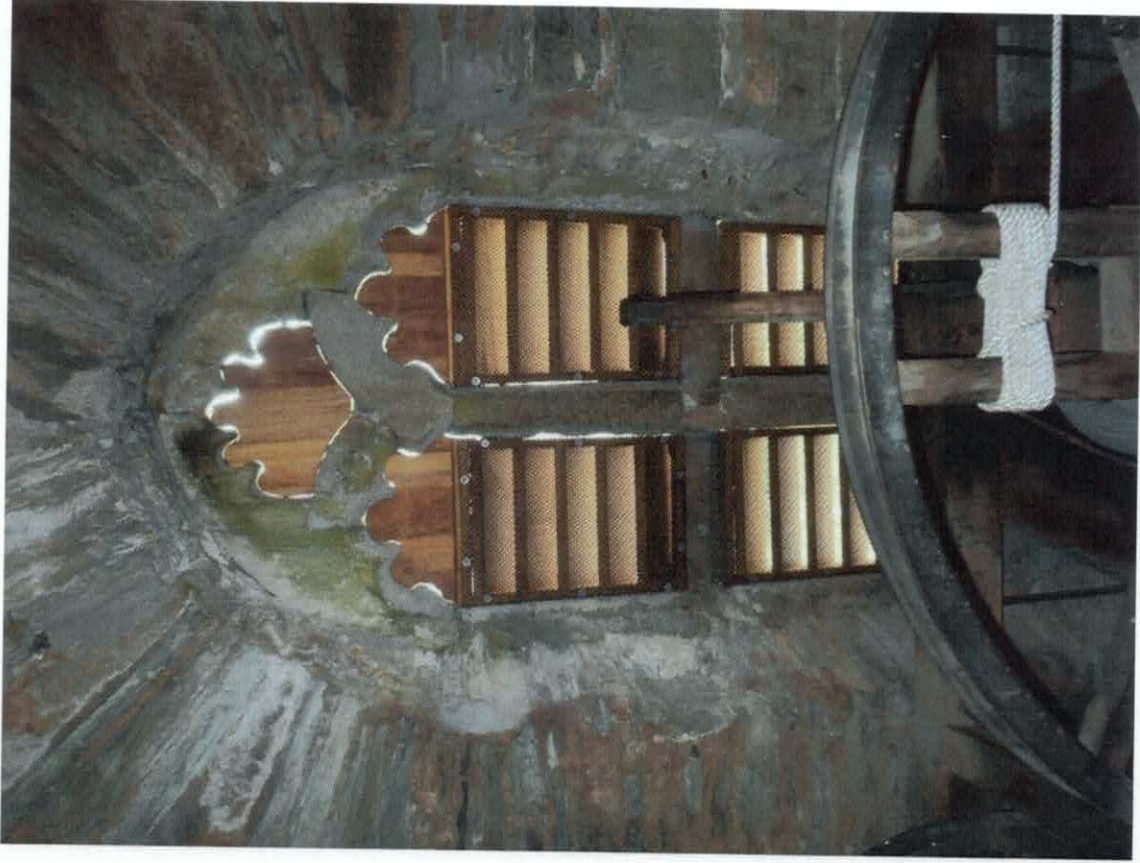
SOUTH BELL CHAMBER OPENING BEFORE REPAIR

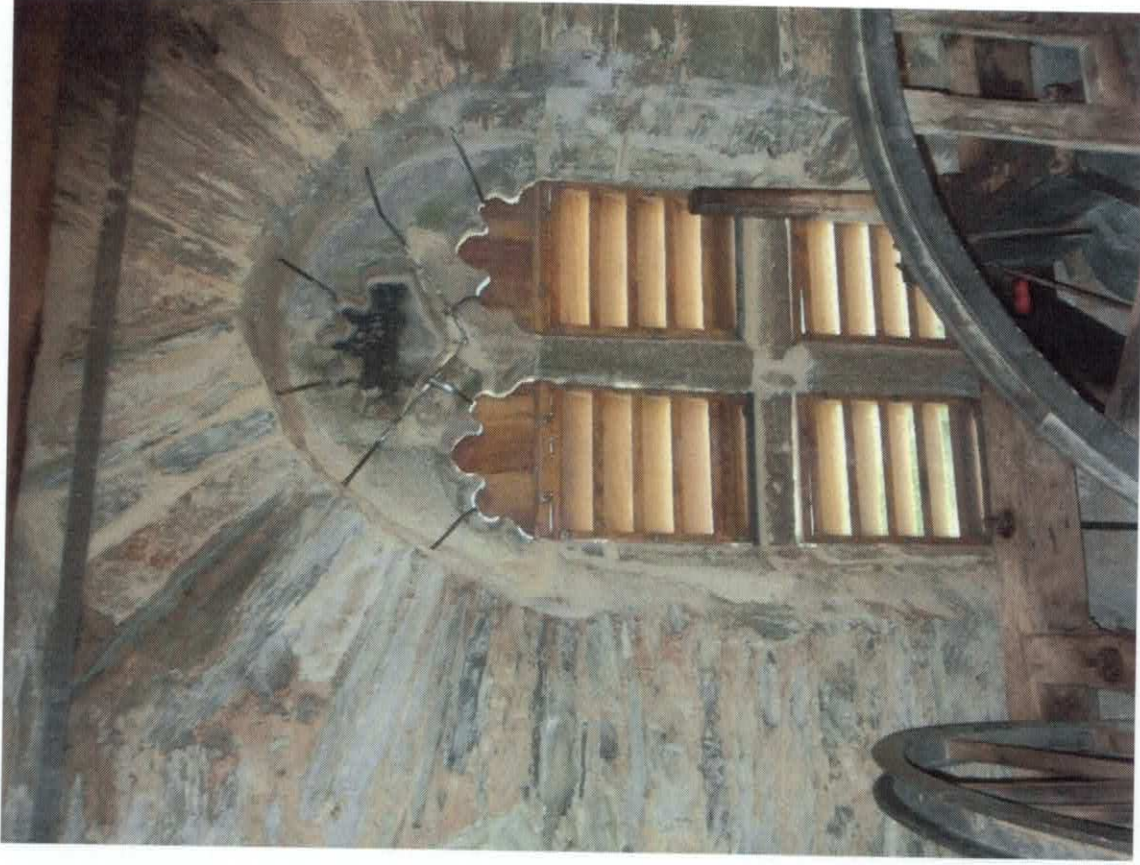
SOUTH BELL CHAMBER OPENING AFTER REPAIR

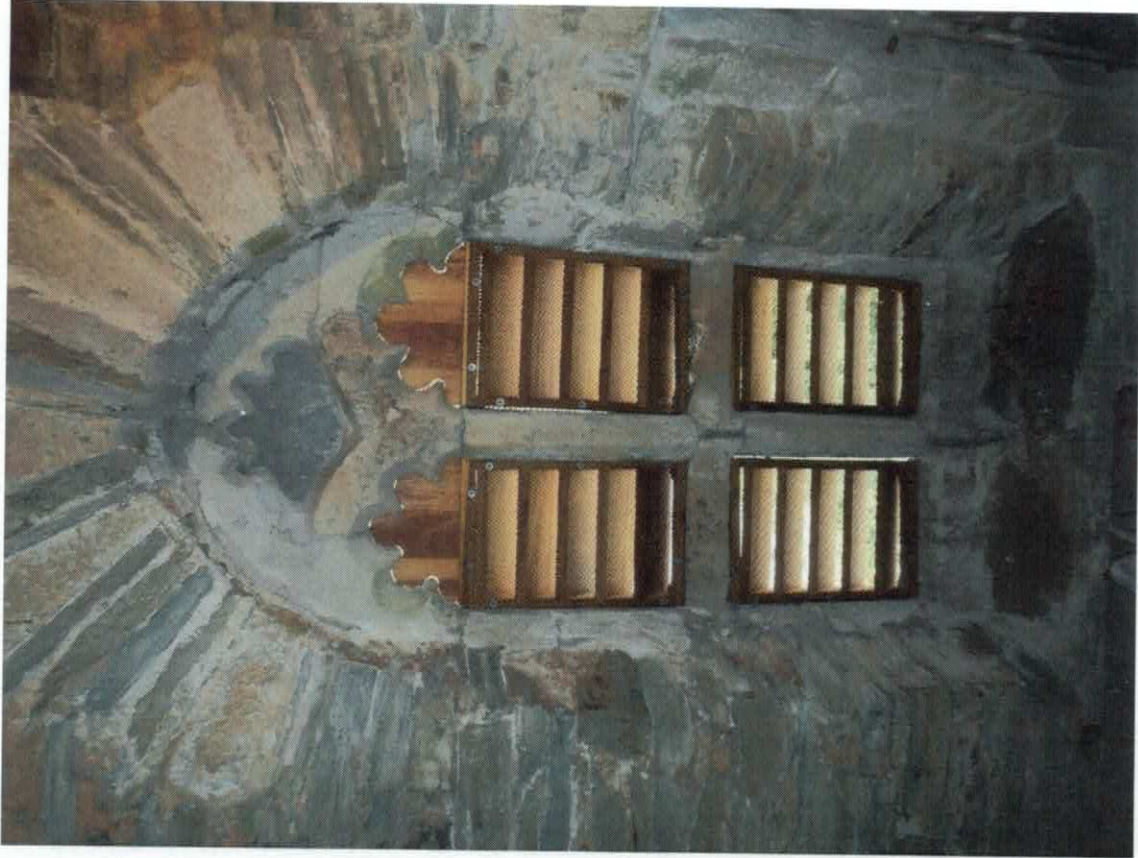
WEST BELL CHAMBER OPENING BEFORE REPAIR

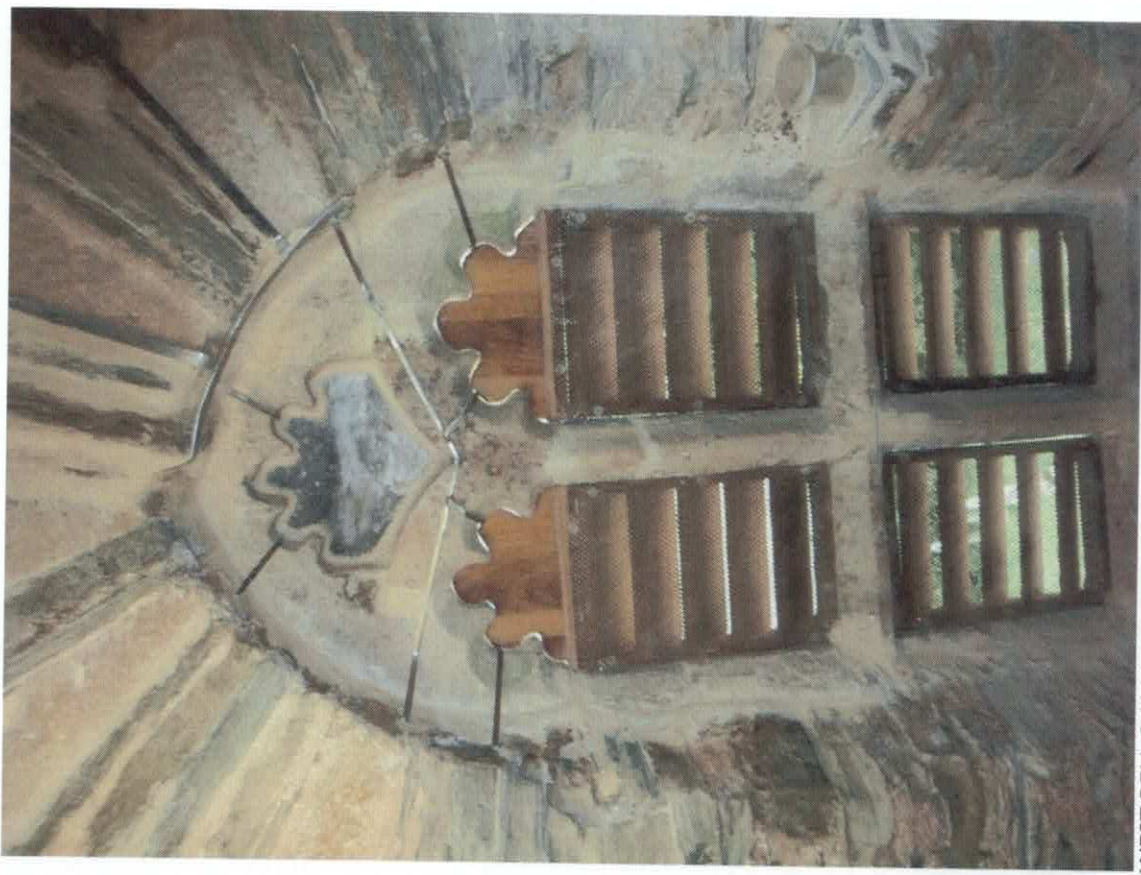
WEST BELL CHAMBER OPENING AFTER REPAIR

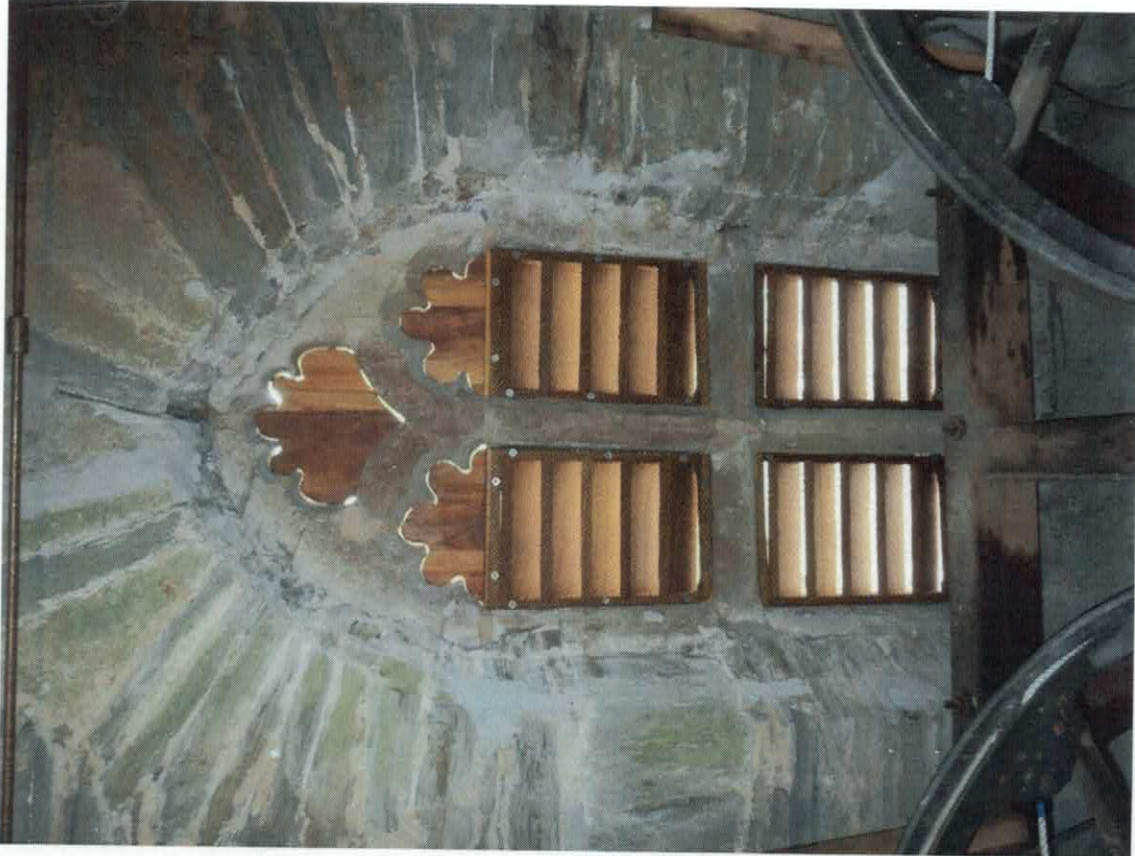
EAST BELL CHAMBER OPENING BEFORE REPAIR

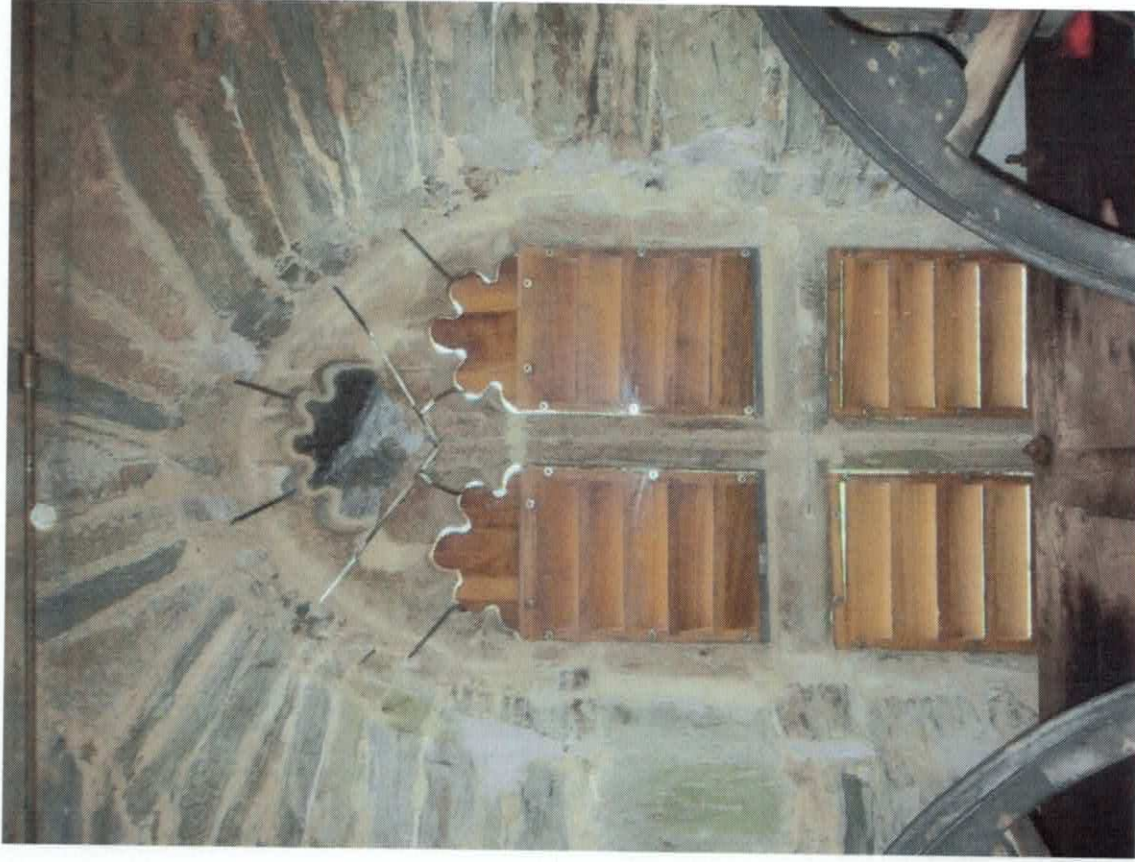
EAST BELL CHAMBER OPENING AFTER REPAIR

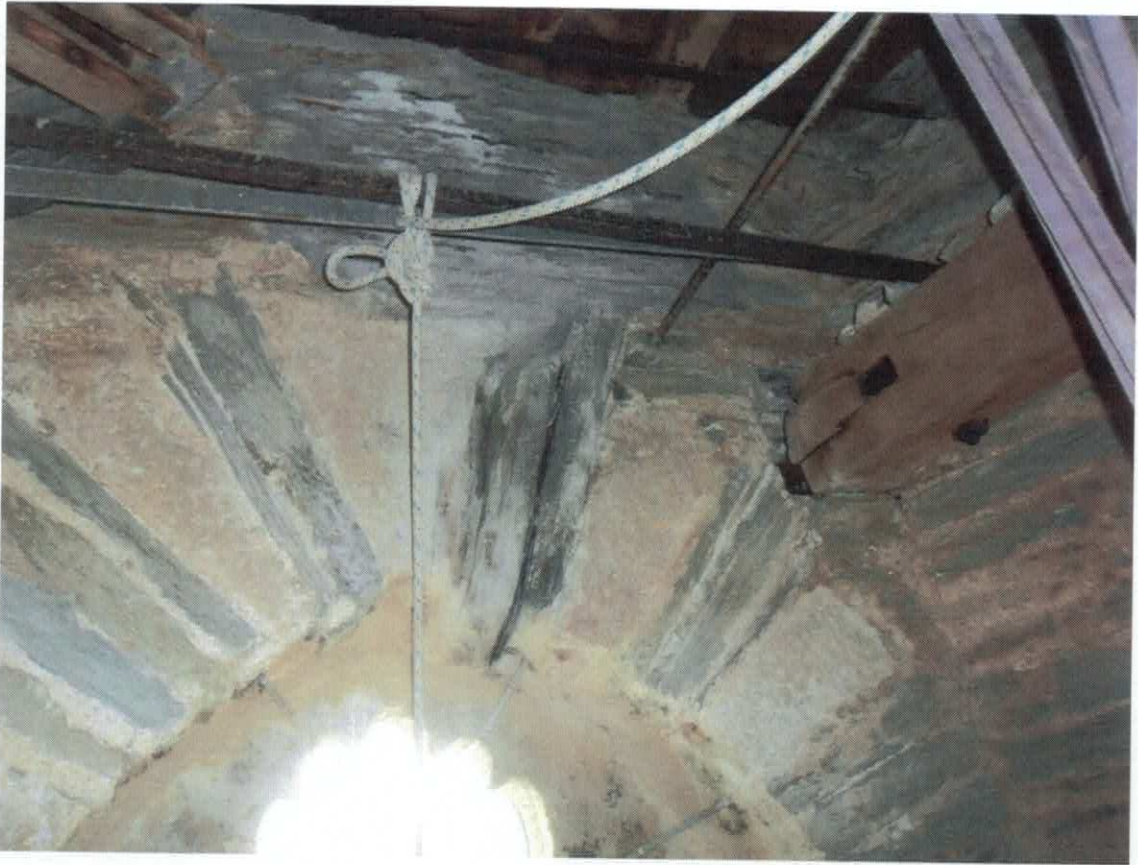
BELL CHAMBER WEST WALL BEFORE REPAIR

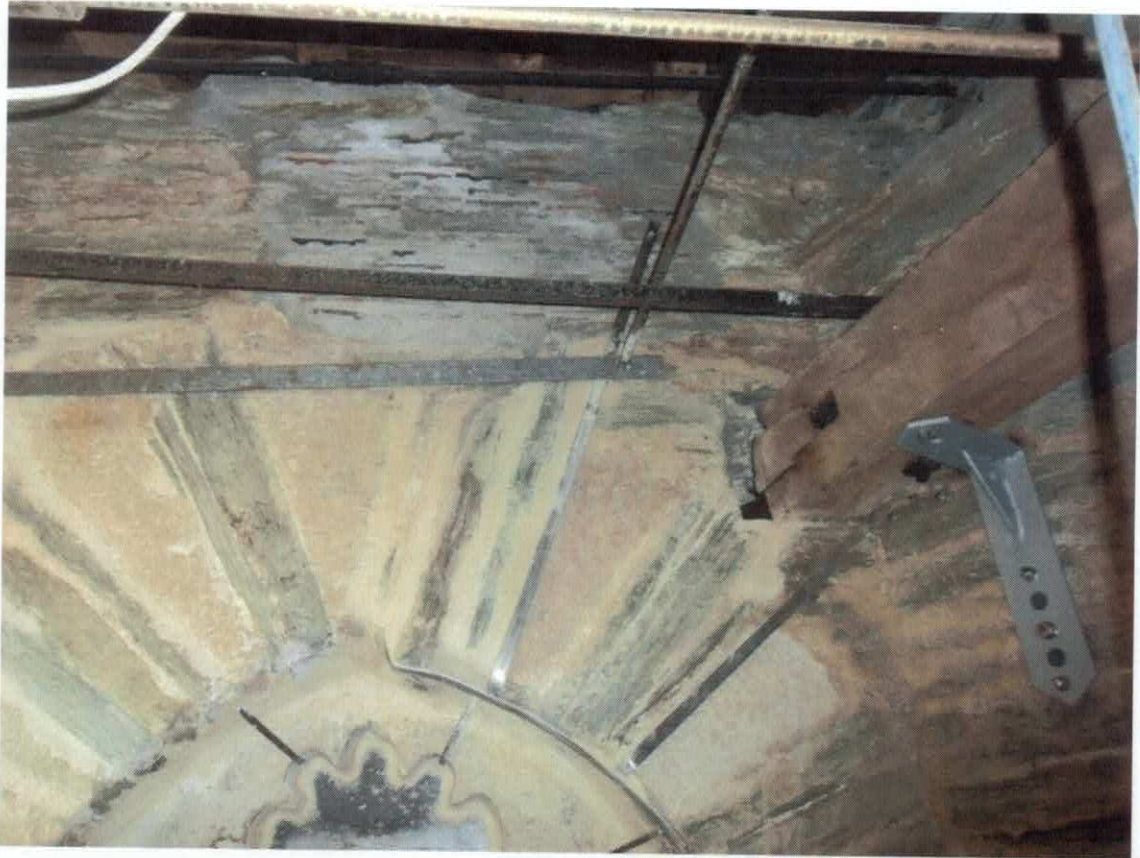
BELL CHAMBER WEST WALL AFTER REPAIR

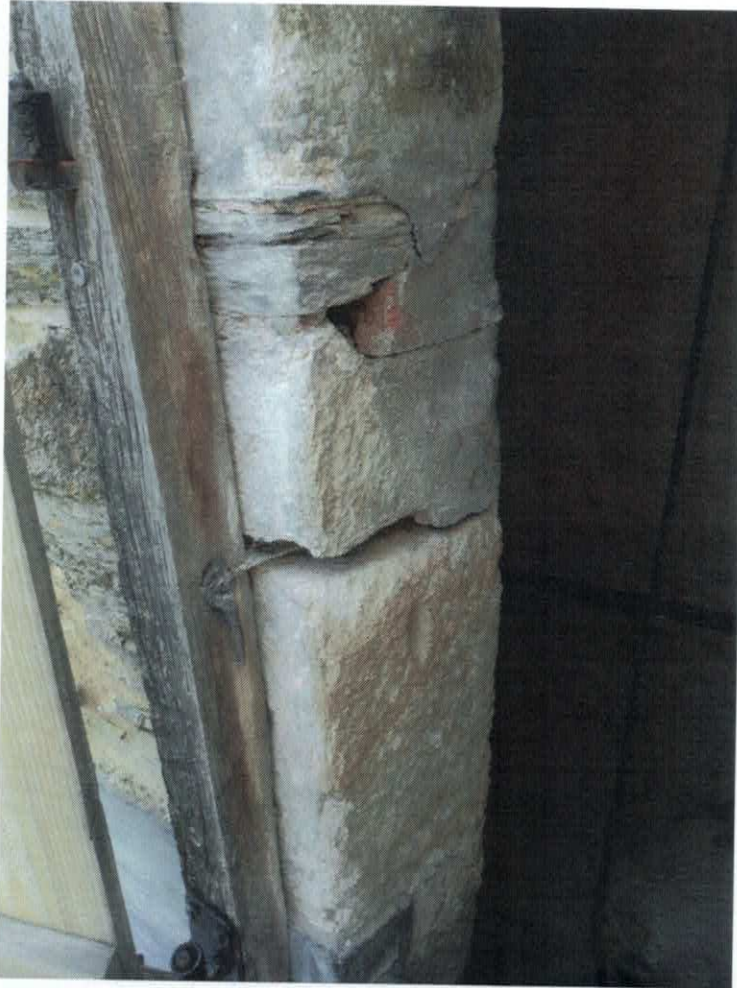
NEW HINGE POST REQUIRED TO
ROOF DOOR, REBED STONework
WHICH HAS BECOME LOOSE
BECAUSE OF HINGE POST FIXINGS,
REFIX NEW HINGE POST IN NEW
LOCATION WITH NEW FIXINGS.

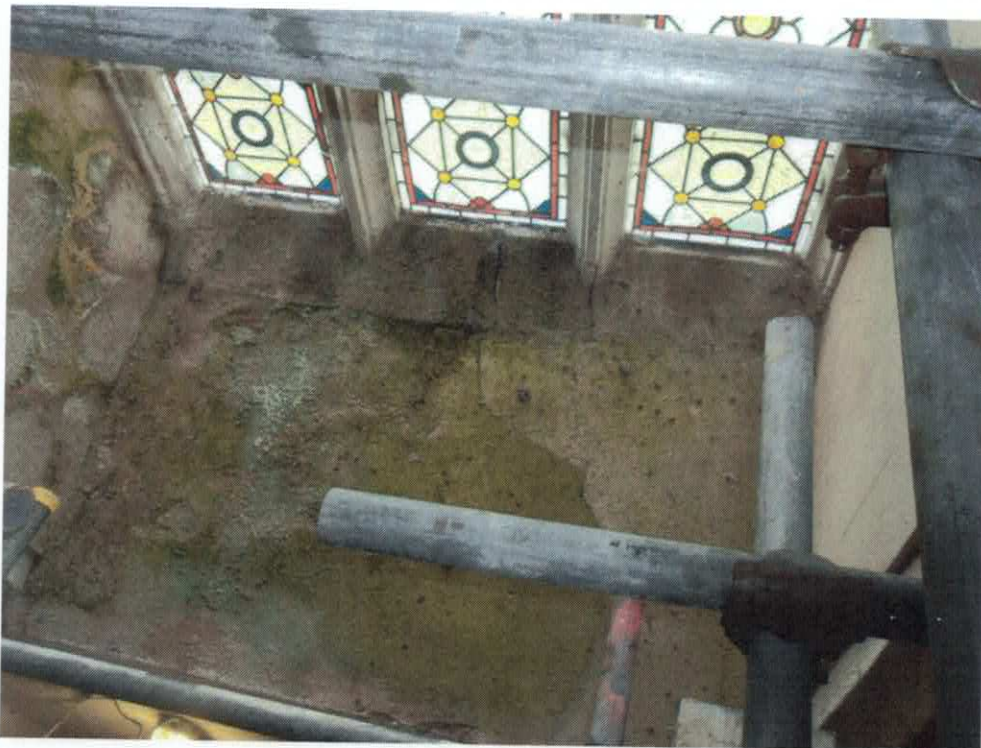
SILL SLOPE TO WEST TOWER WINDOW, RENDER IS CRACKING AND COMING AWAY FROM
STONework AND STONES UNDERNEATH ARE LOOSE.

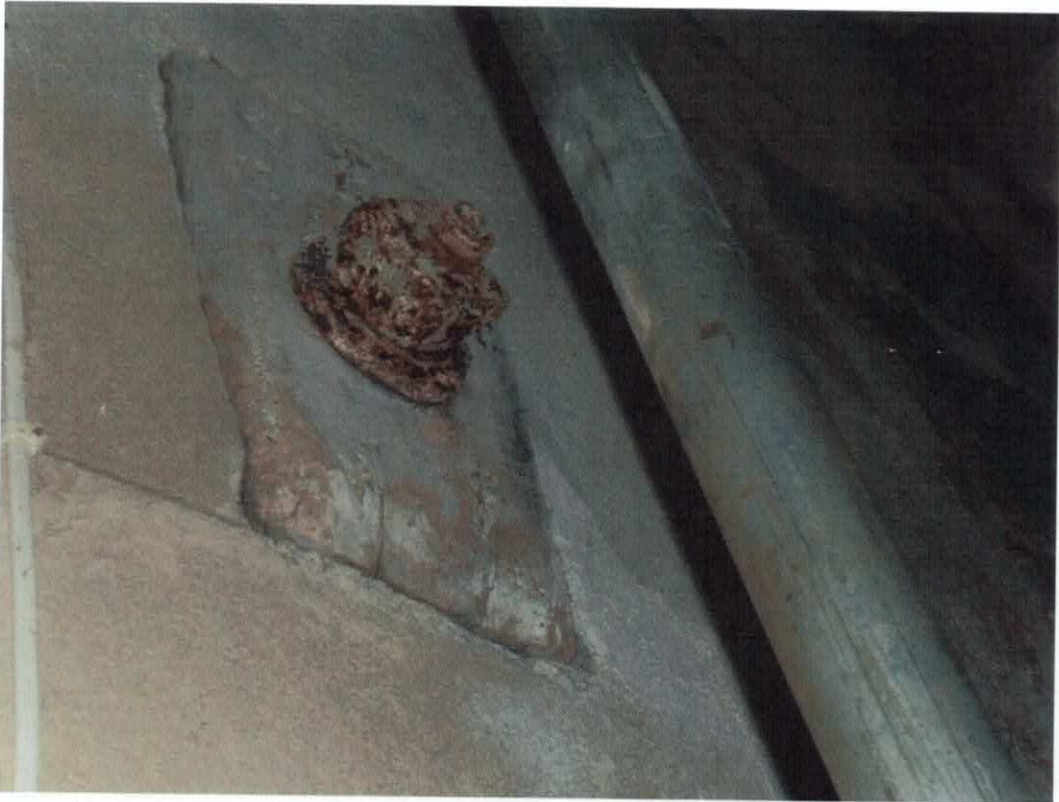
OAK PAD TO BOLT TO NAVE ROOF, EXISTING PAD IS ROTTEN AND HAS WOODWORM.

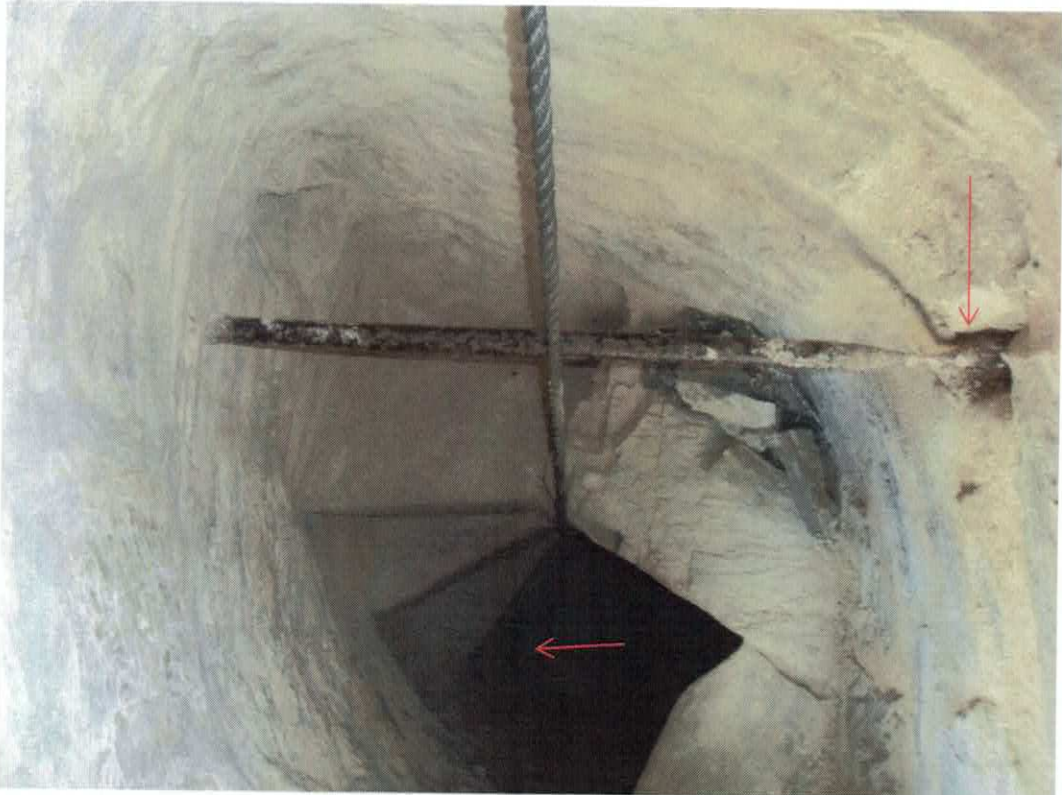
STAINLESS STEEL PLATE REPAIR TO TOWER STEP, NORTH/SOUTH TIE BAR HAS CORRODED WHERE IT ENTERS THE NORTH WALL.

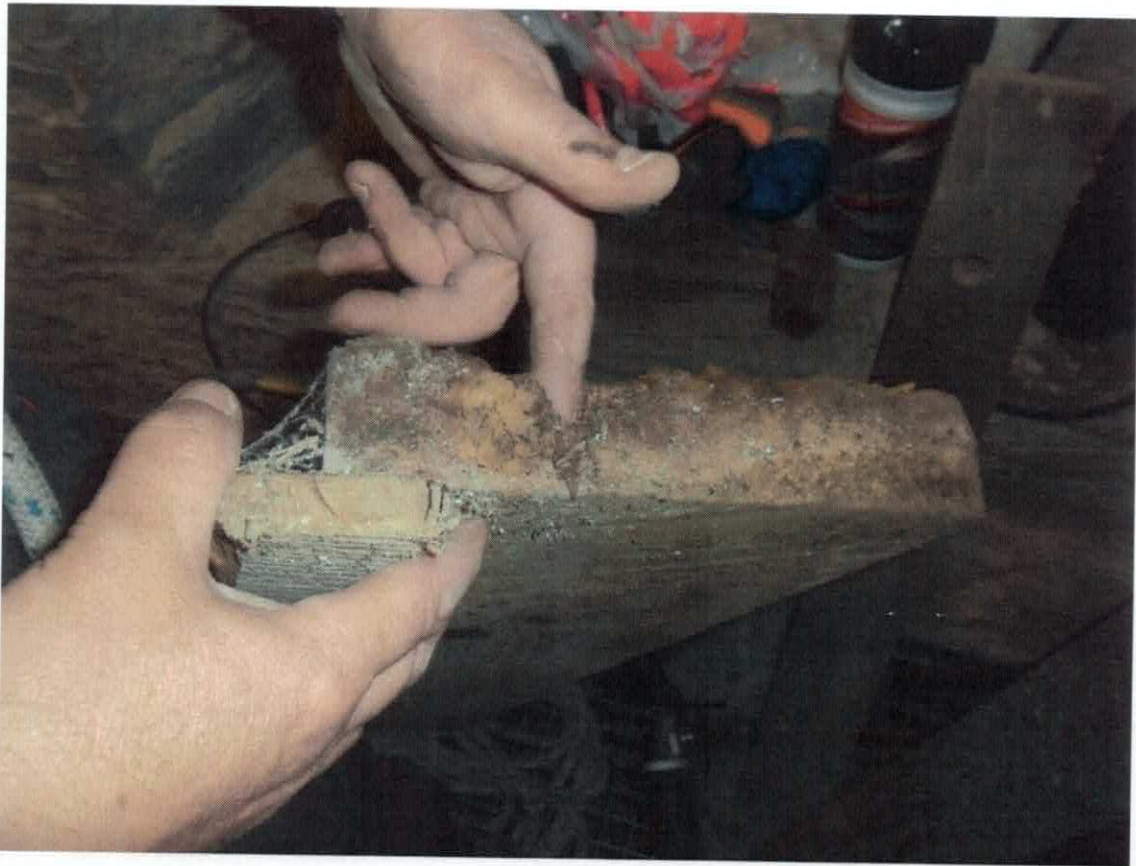
ROTTEN BOARDS WHICH FORMED THE HATCH UNDER THE TENOR BELL, NORTH SIDE WERE ROTTEN AND SOUTH SIDE ONLY JUST RESTING ON A ROUNDED BEM EDGE.
