PEARSON LUBBOCK ARCHITECTS
BELL CHAMBER OPENINGS BEFORE AND AFTER FIRST PHASE

ST WINNOW CHURCH TOWER FIRST PHASE

5TH OCTOBER 2016

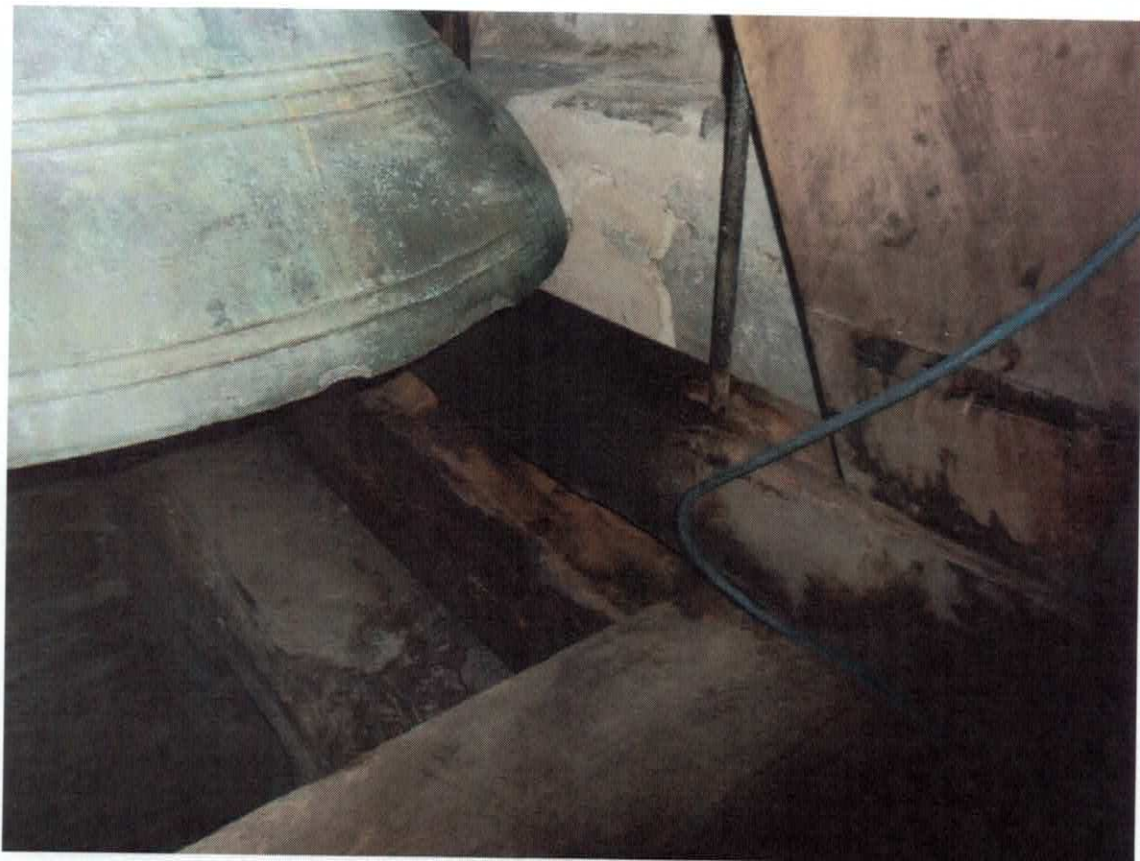
ROTTED SOUTH BEAM TO BELL CHAMBER FLOOR AND BOTTOM RAIL OF BELL FRAME.

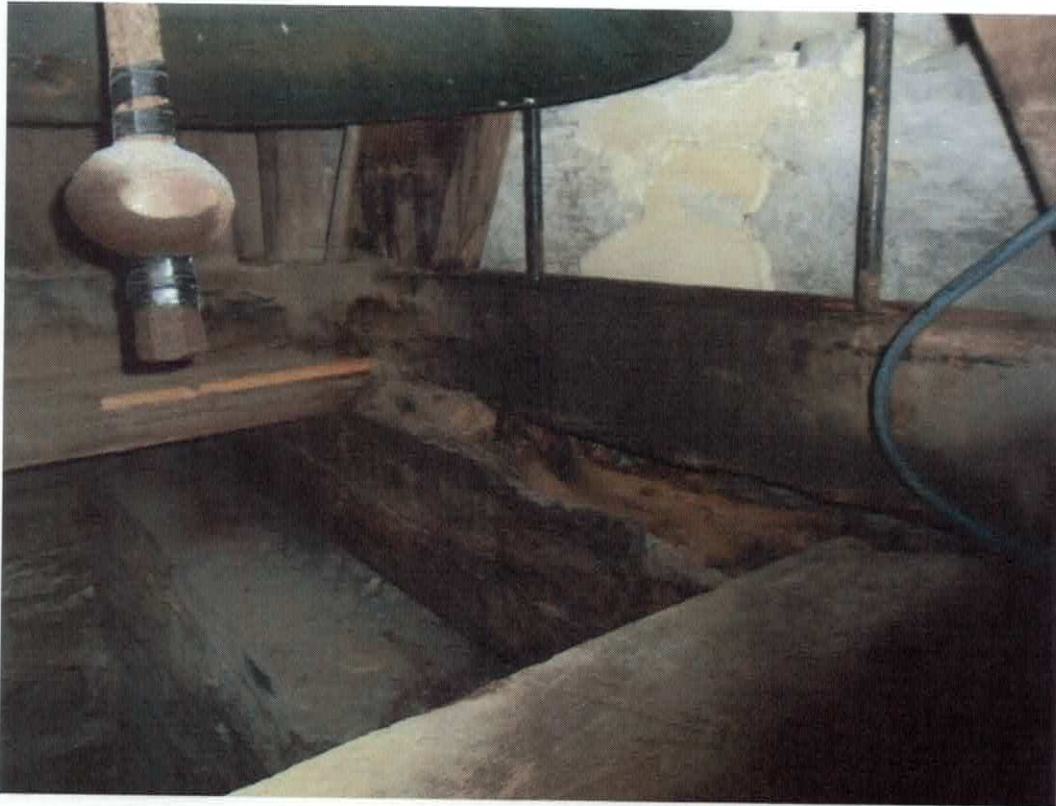
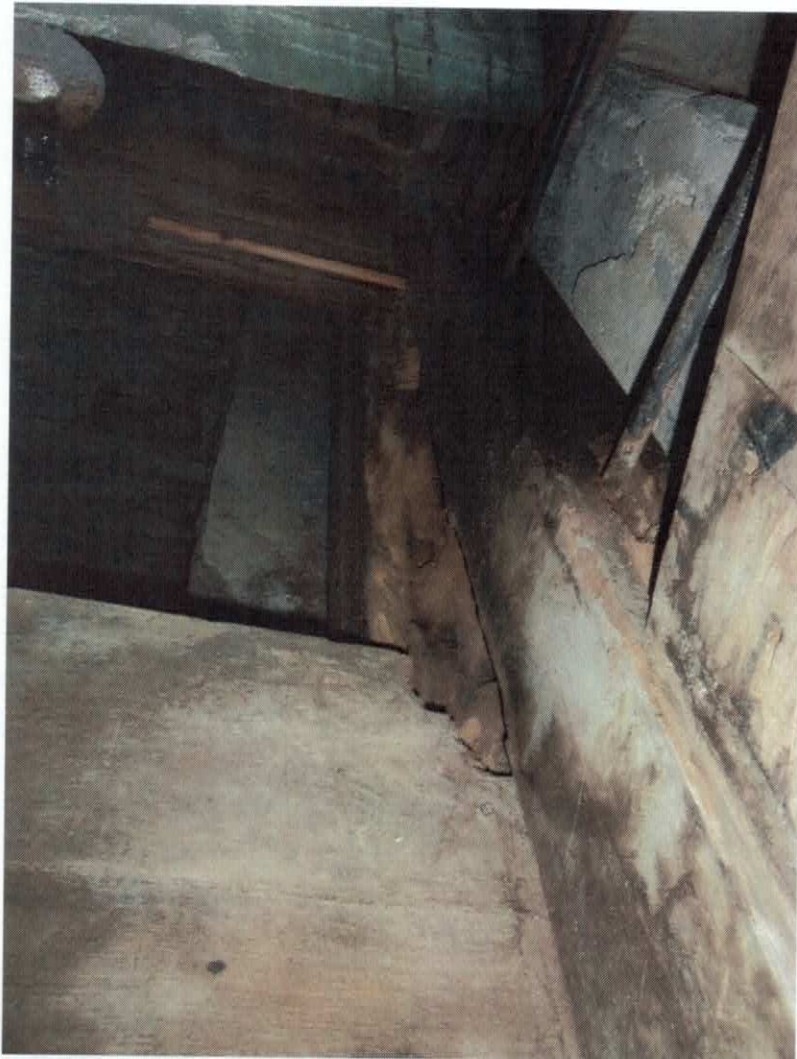
A SECTION OF THE BEAM 5 FOOT LONG BY UP TO 6 INCHES DEEP IS ROTTEN, THE BEAM IS 13 FEET BY 10⁵/₈ INCHES BY 8" INCHES, THE BEAM IS ALSO ROTTEN AND SOFT AT ITS WEST END.

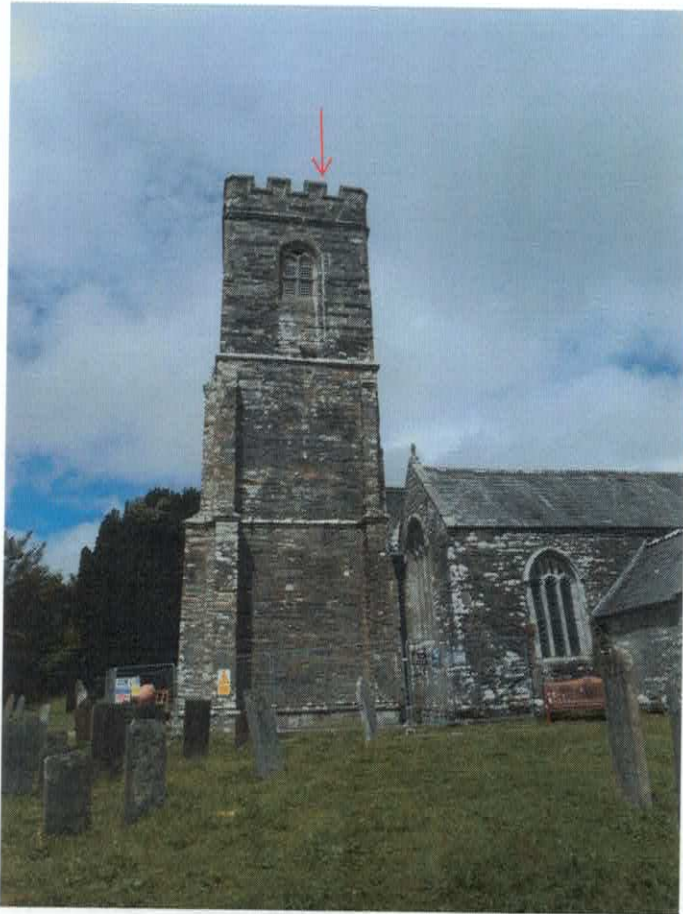
A MERLON CAPSTONE TO THE SOUTH PARAPET WALL OF THE TOWER ROOF (940X250X260MM) HAS CRACKED VERTICALLY DOWN ITS LENGTH.

IF RAINWATER GETS INTO THE CRACK AND FREEZES THE OUTER PIECE COULD FALL INTO THE CREMATED REMAINS AREA AT THE BASE OF THE SOUTH SIDE OF THE TOWER.

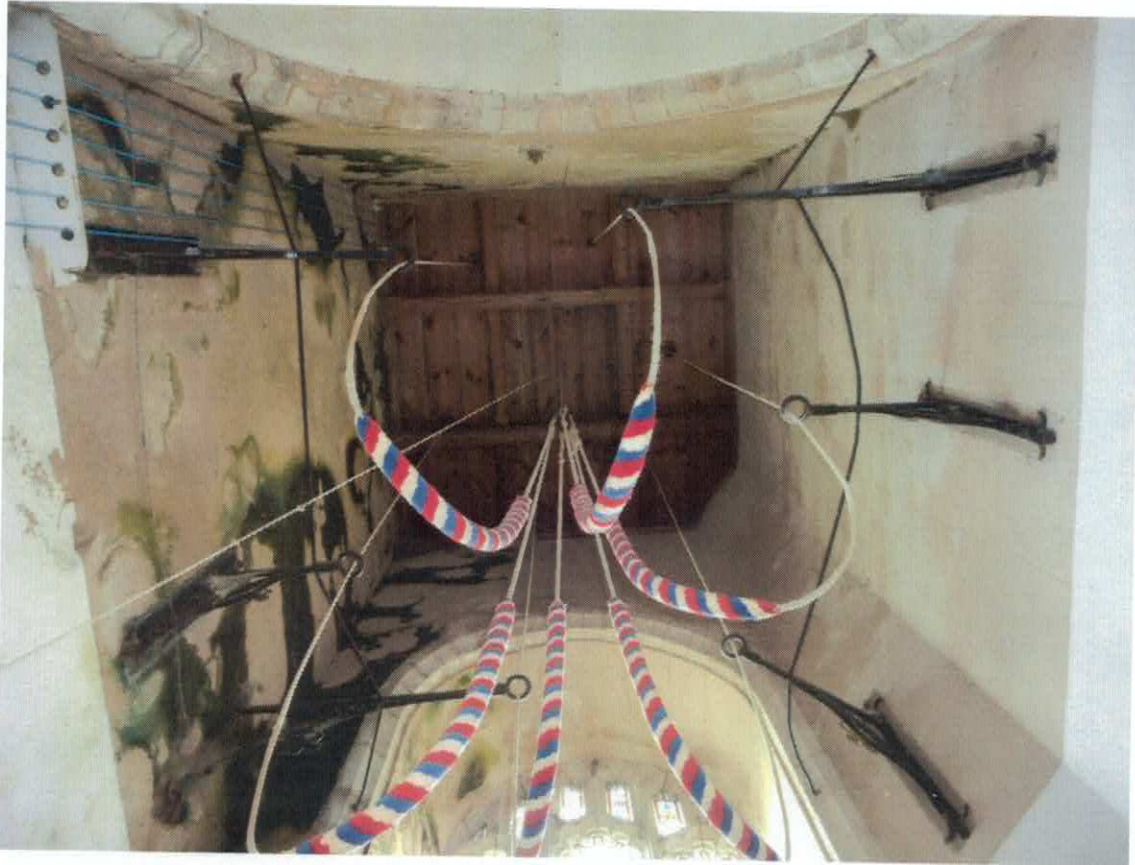
LOOKING UP INSIDE THE TOWER TO LOWER CHAMBER FLOOR BEFORE THE REMOVAL OF THE ROTTEN FLOOR.

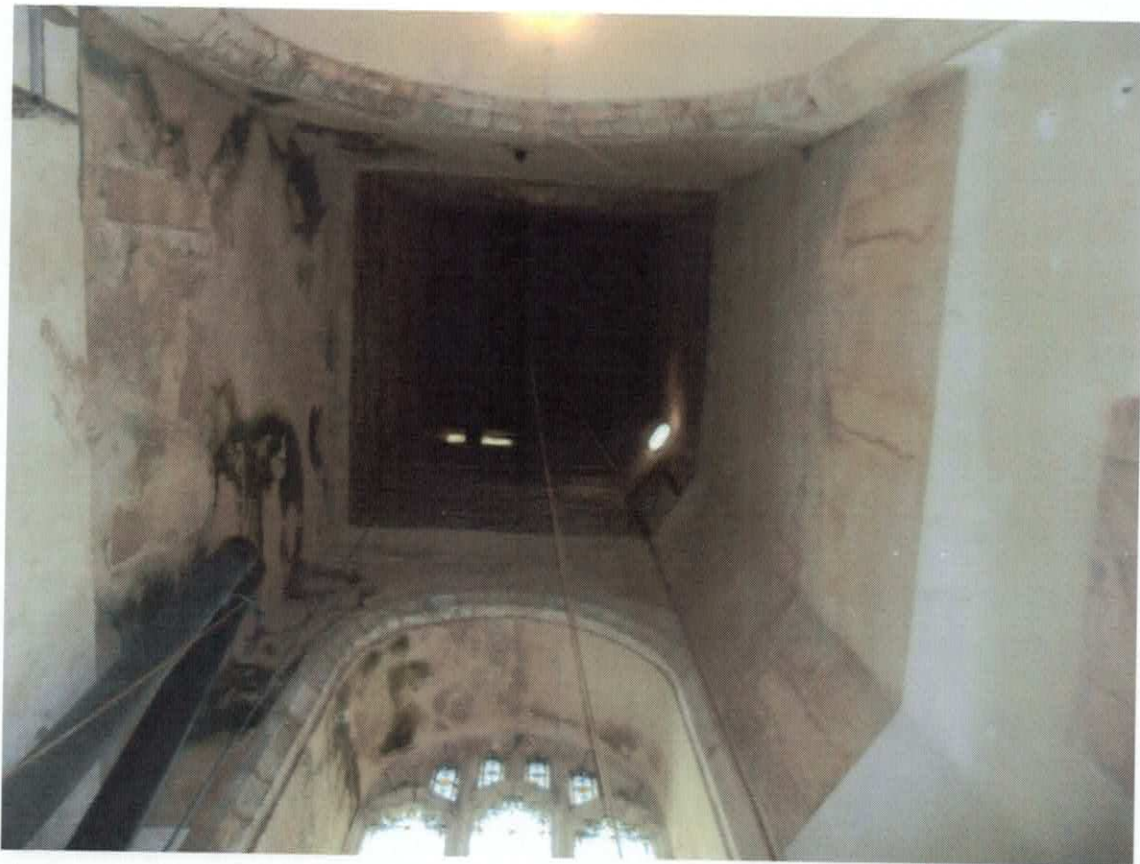
LOOKING UP INSIDE THE TOWER TO THE BELL CHAMBER FLOOR AFTER REMOVAL OF THE ROTTEN FLOOR

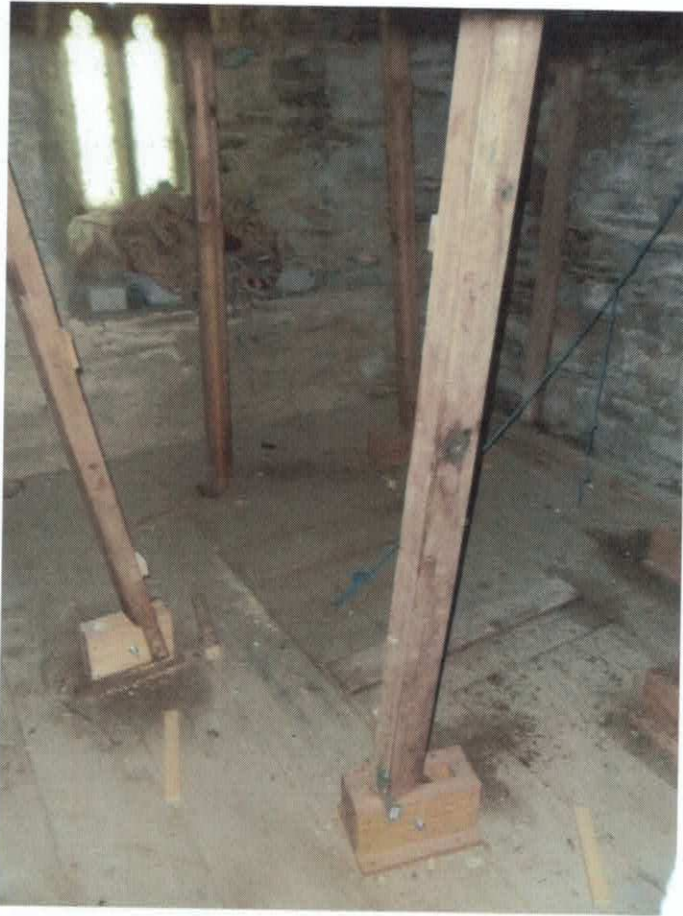
LOOKING INTO THE LOWER CHAMBER
FROM THE STAIR DOORWAY BEFORE
REMOVAL OF THE ROTTEN FLOOR

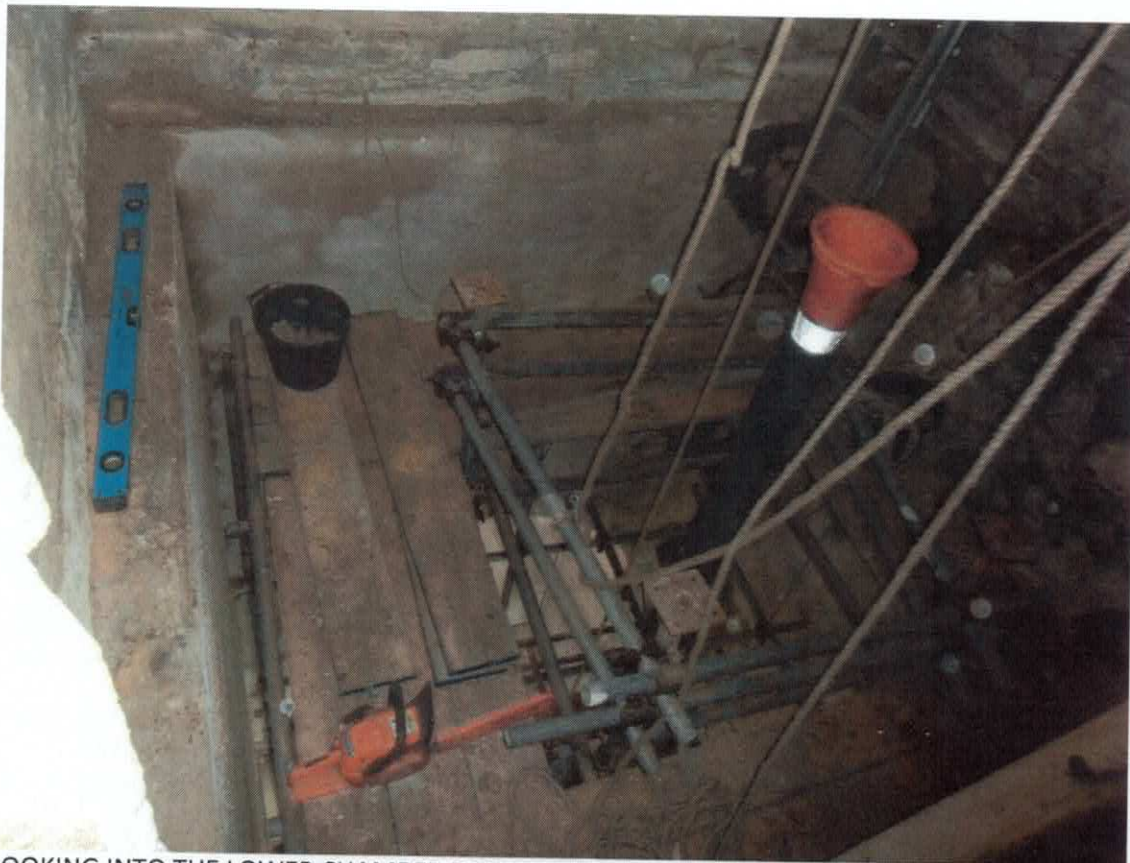
LOOKING INTO THE LOWER CHAMBER SPACE FROM THE STAIR DOORWAY AFTER REMOVAL OF THE
ROTTEN FLOOR

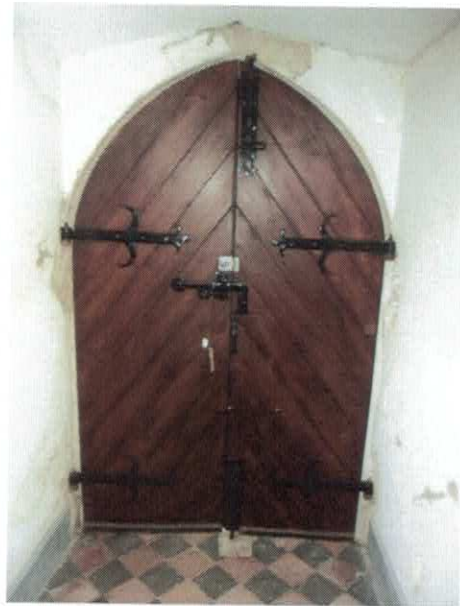
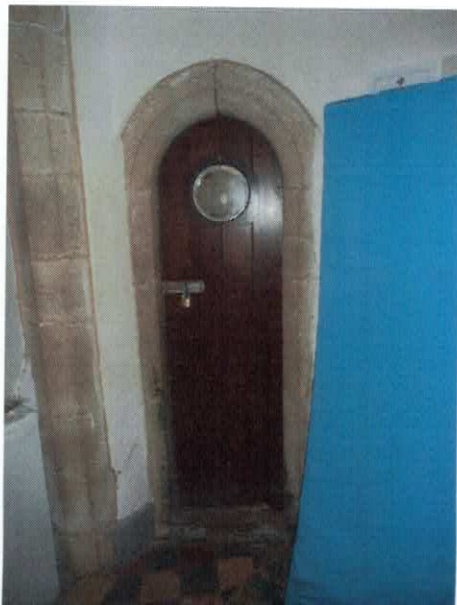
DOOR TO
TOWER STAIRS
OUTER LAYER
REMOVED,
ORIGINAL
DOOR
RESTORED AND
REHUNG

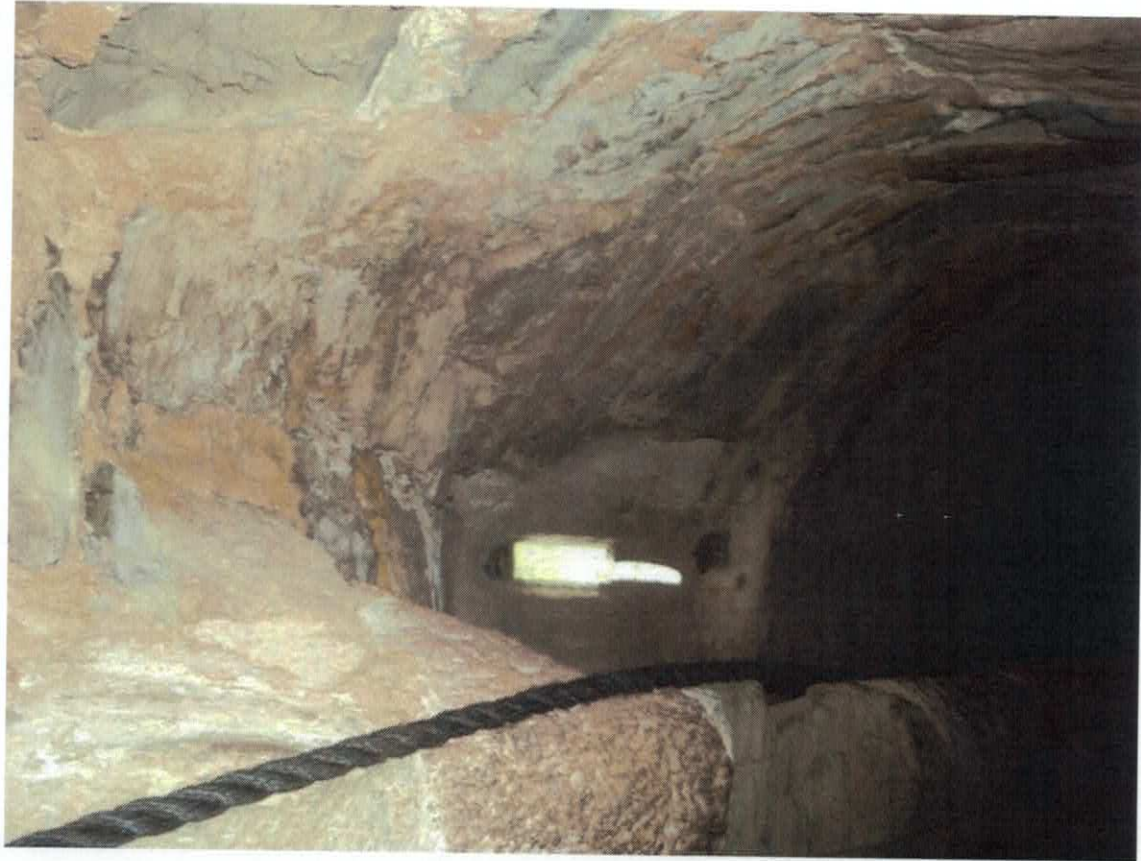
STAIR WINDOW AND CRACKED LINTEL BEFORE REPAIR

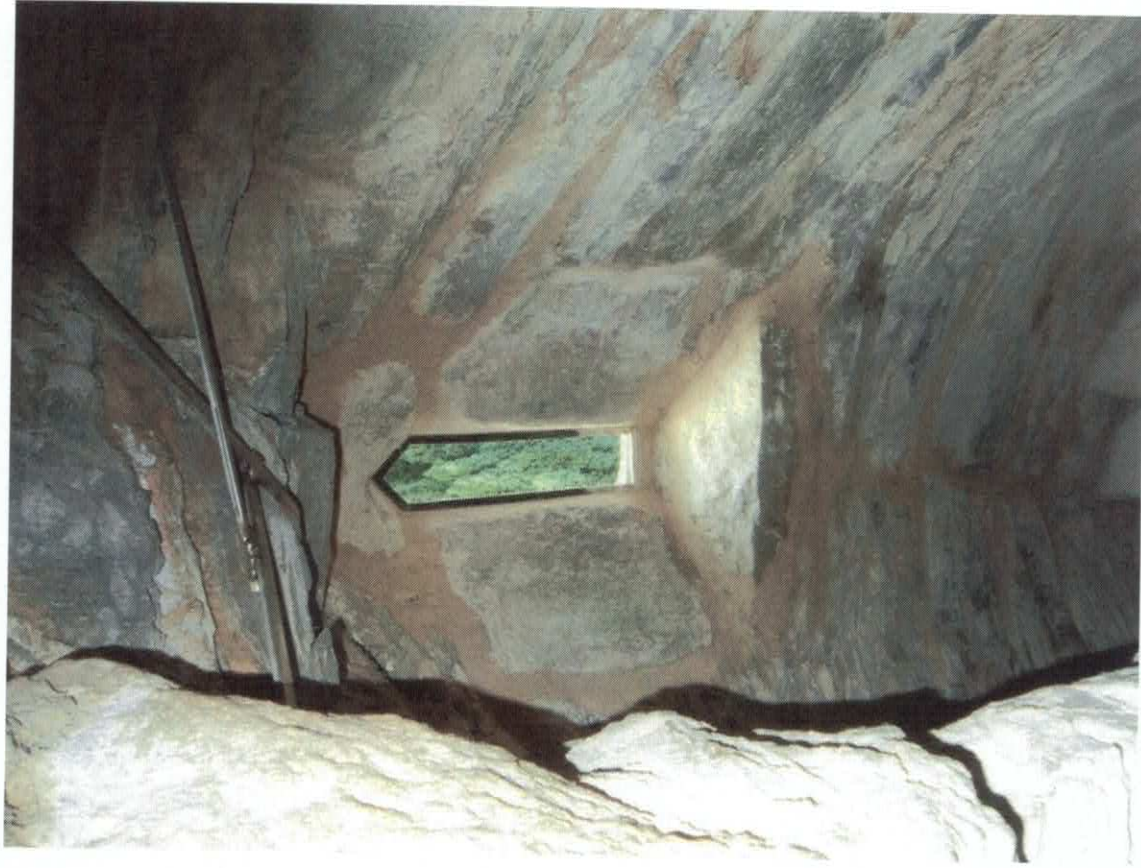
STAIR WINDOW AND CRACKED LINTEL AFTER REPAIR
