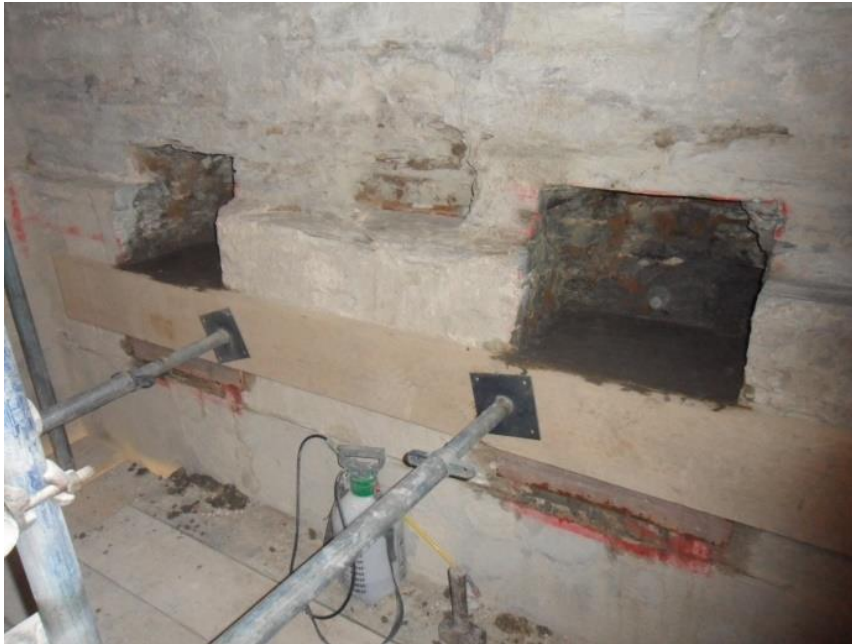
CONCRETE PADSTONES FOR THE NEW BELL FRAME CAST IN THE NEW POCKETS IN THE SOUTH WALL

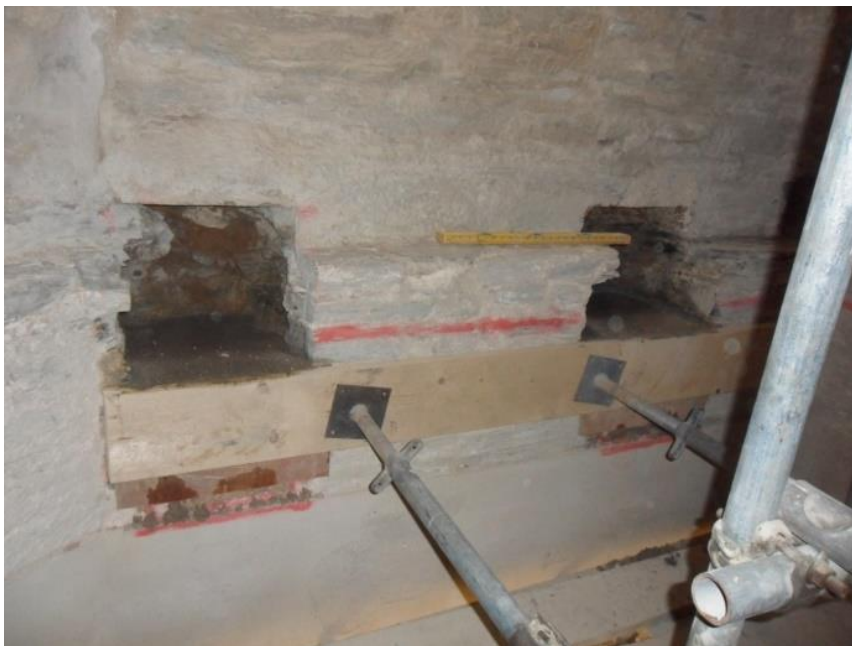
CONCRETE PADSTONES FOR THE NEW BELL FRAME CAST IN THE NEW POCKETS IN THE NORTH WALL

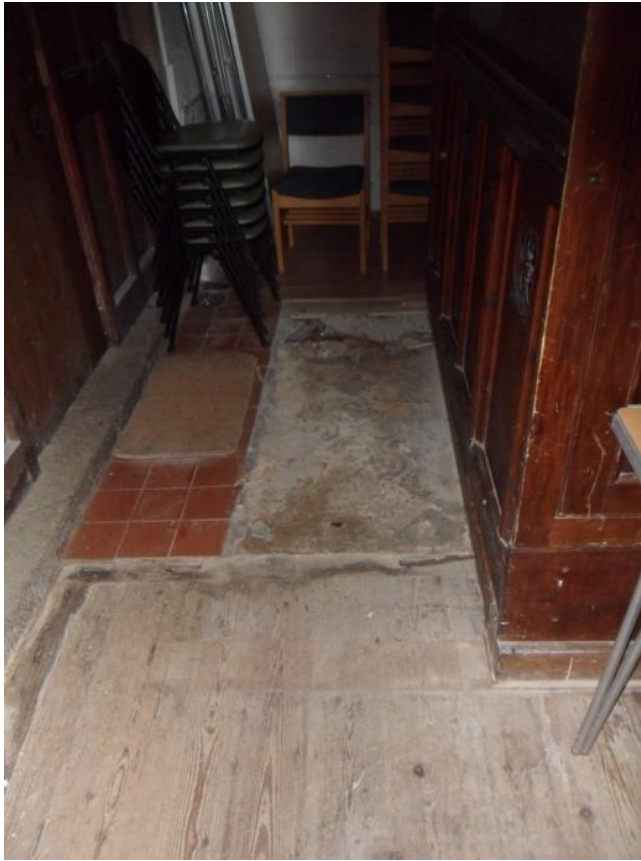
BEFORE START OF WORK TO CREATE THE NEW GULLEY
TO HOLD THE ELECTRICAL WIRING

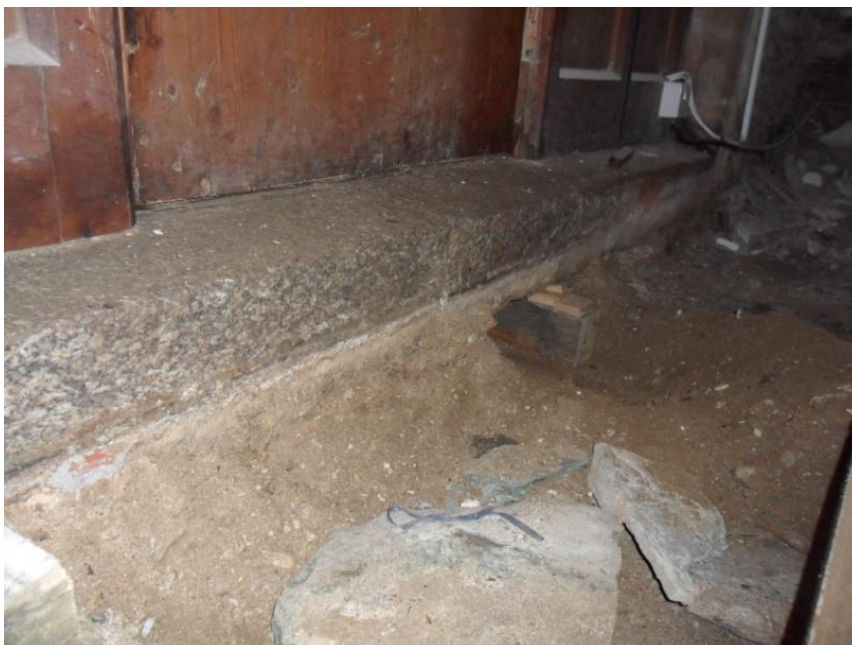
DURING THE EXCAVATION WORK IT BECAME CLEAR THAT A PROPER BED
FOR THE STEPS HAD NEVER BEEN CREATED CONSEQUENTLY THEY ROLLED
FORWARDS

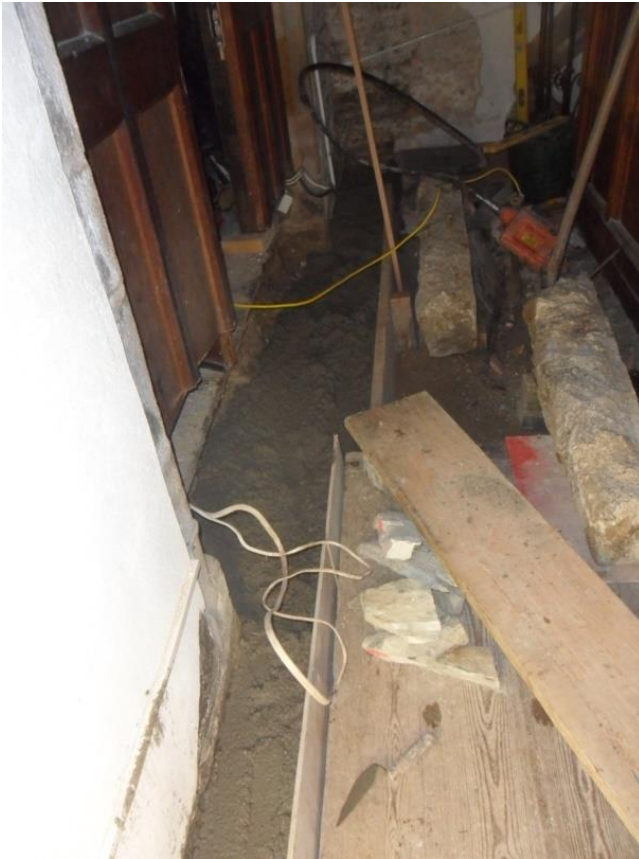
THE GRANITE STEPS TAKEN OUT AND A NEW CONCRETE BED FORMED THIS REQUIRED THE DISMANTLING OF THE BASE OF THE SCREEN, THIS HAS NOW BEEN REPAIRED

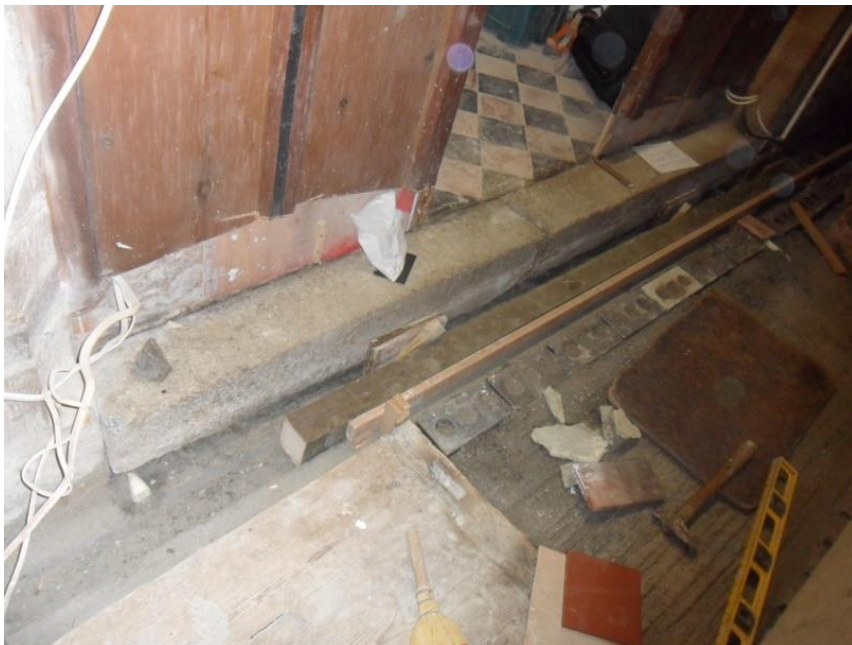
THE PIECES OF GRANITE BACK IN PLACE ON THEIR NEW BED, THE STEP IS NOW LEVEL.

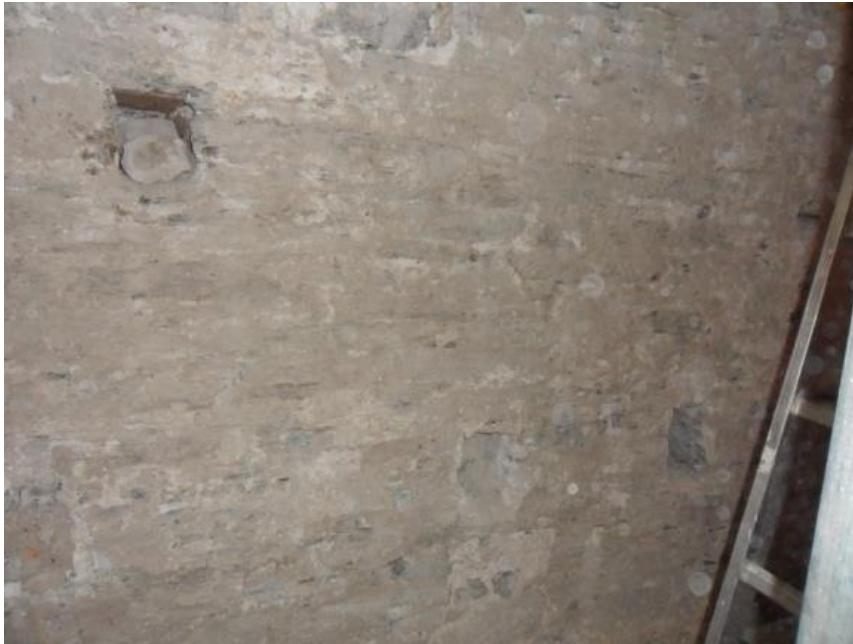
AFTER REMOVAL OF THE RENDER ON THE TOWER WALLS PATCHES OF LIME PLASTER ARE STILL EVIDENT ON THE WALLS SHOWING THAT THIS WAS THE ORIGINAL FINISH BEFORE THE HEAVY CEMENT MORTAR WAS APPLIED

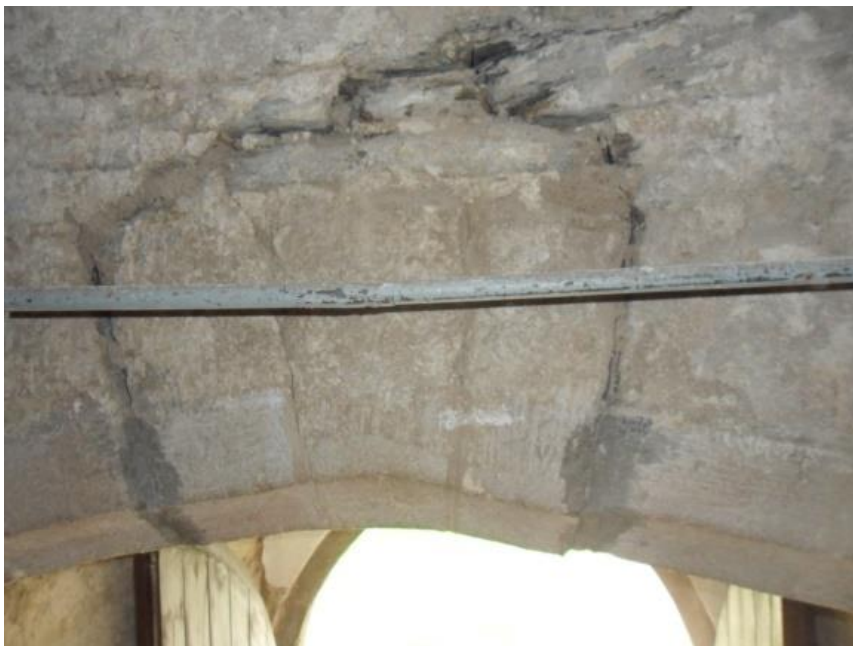
ARCH ABOVE TOWER WEST DOOR

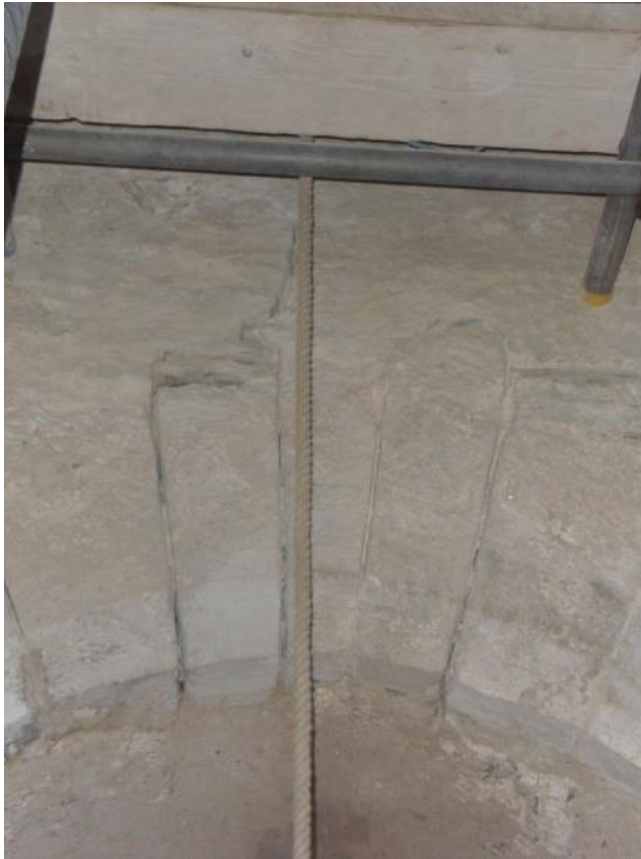
ARCH ABOVE TOWER WEST WINDOW

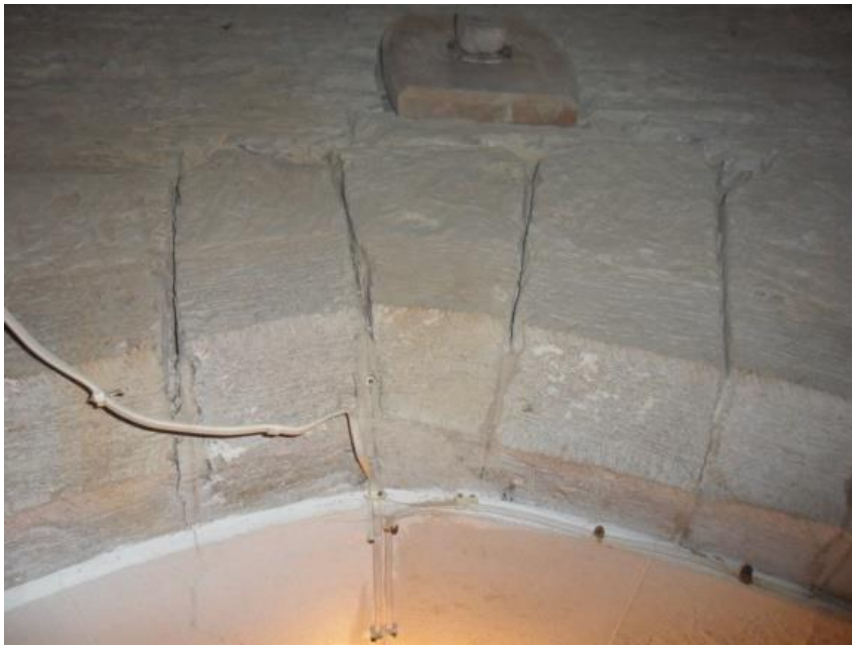
ARCH BETWEEN TOWER AND NAVE ON THE TOWER SIDE

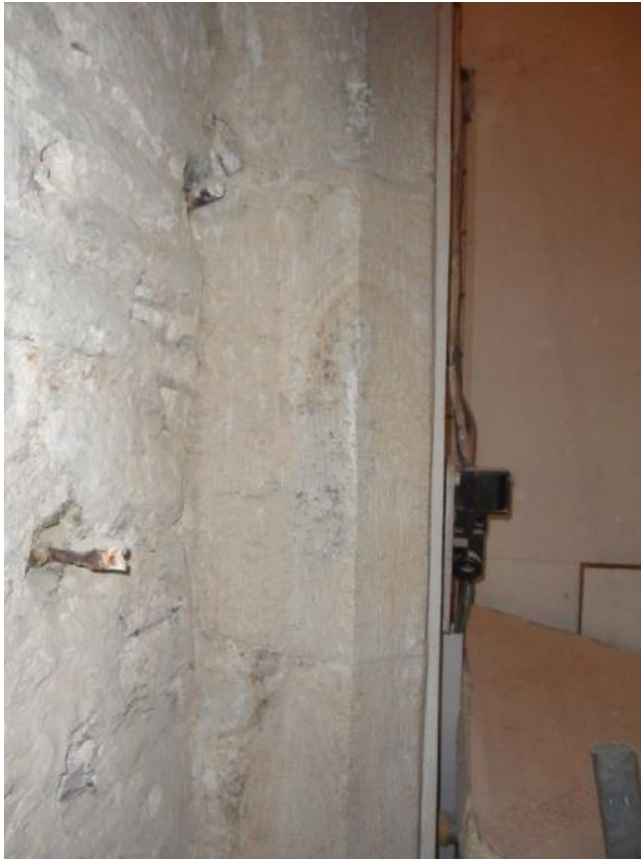
CORODING IRONWORK BEDDED INTO THE TOWER NORTH WALL,
THERE IS ALSO SOME IN THE SOUTH WALL

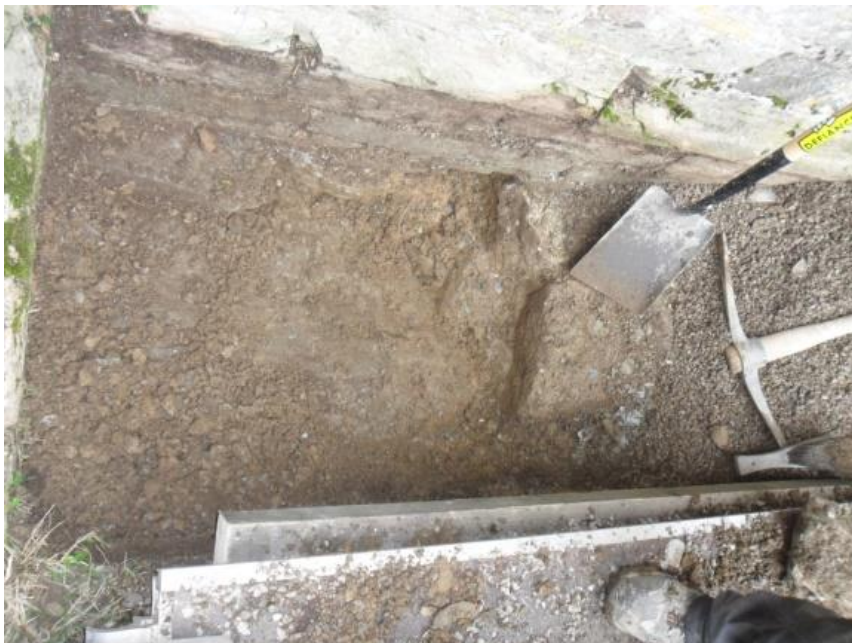
EXTERNAL TRENCH ON THE SOUTH SIDE OF THE TOWER, THIS HAS BEEN
EXCAVATED DOWN TO THE BED ROCK ON WHICH THE TOWER HAS BEEN BUILT
AND IS NOW BEING REFILLED WITH STONES TO DRAIN MOISTURE AWAY FROM
THE BASE OF THE WALL

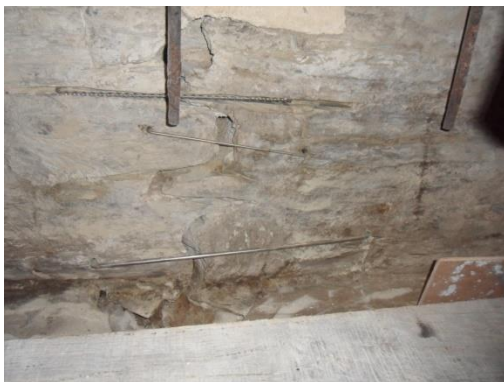
SOUTH

CRACKS BENEATH BELL CHAMBER FLOOR
