## PEARSON LUBBOCK ARCHITECTS

## ST WINNOW TOWER START OF SECOND PHASE

17 NOV 2016

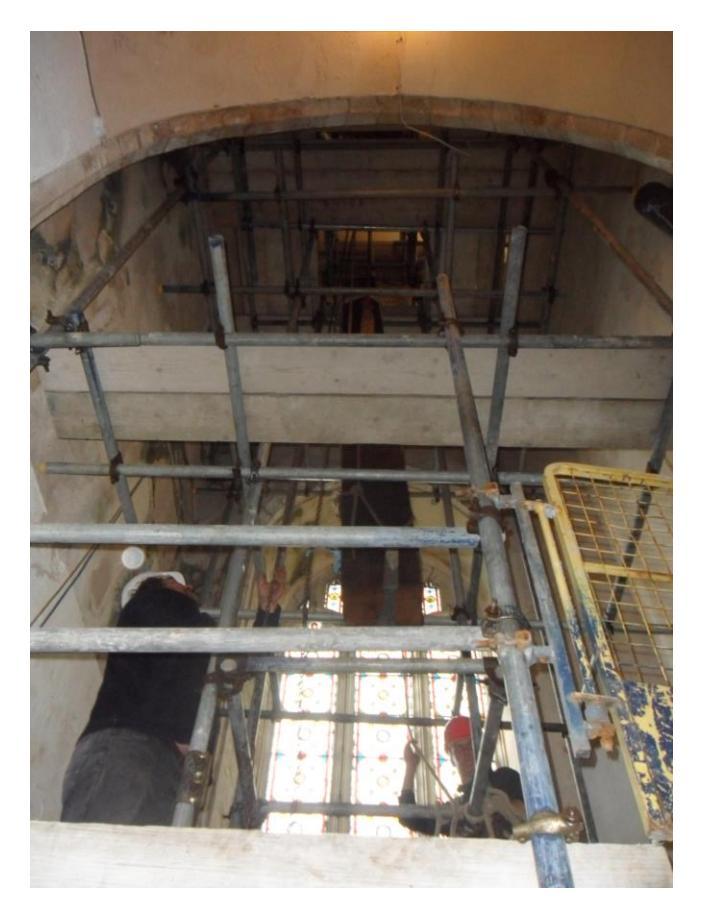
RAISING THE NEW BEAM (13 FT LONG, WEIGHING 400KG)...

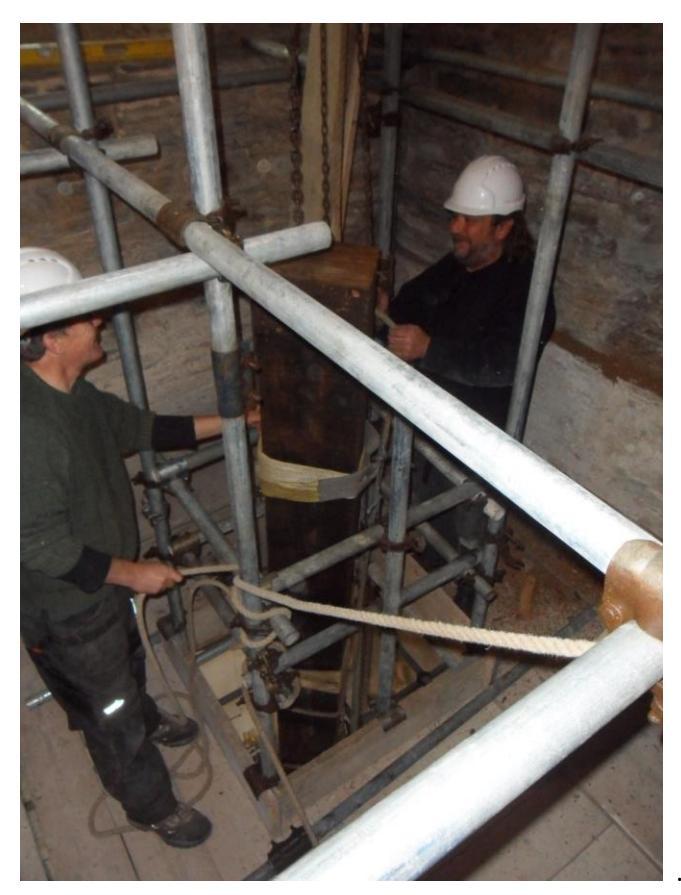
... UP TO THE LOWER CHAMBER...

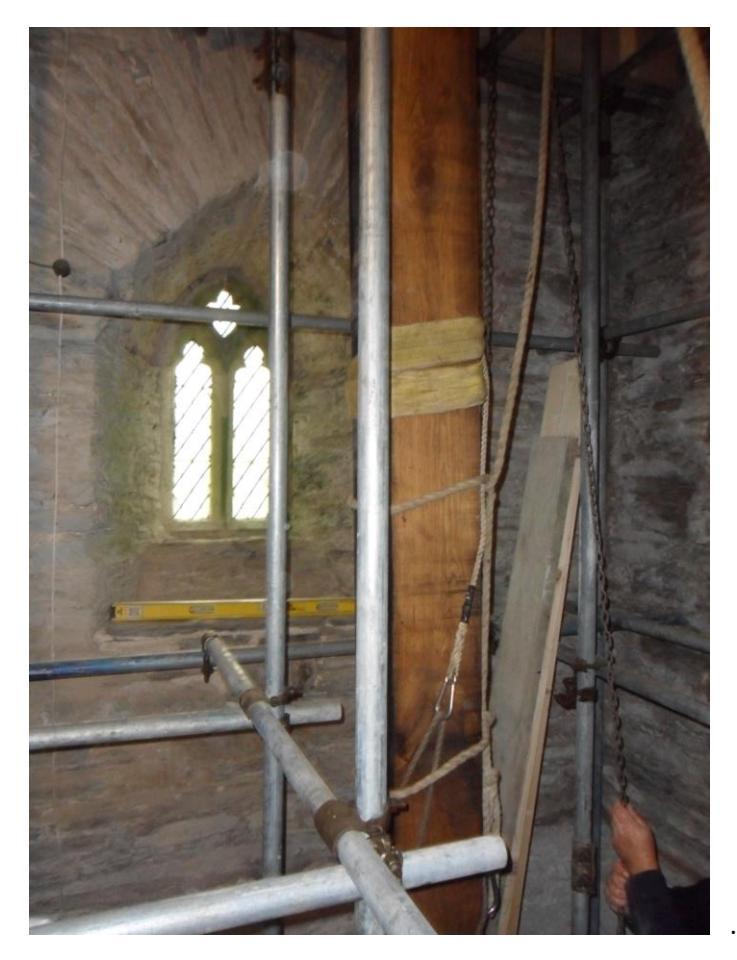
...THROUGH THE LOWER CHAMBER...

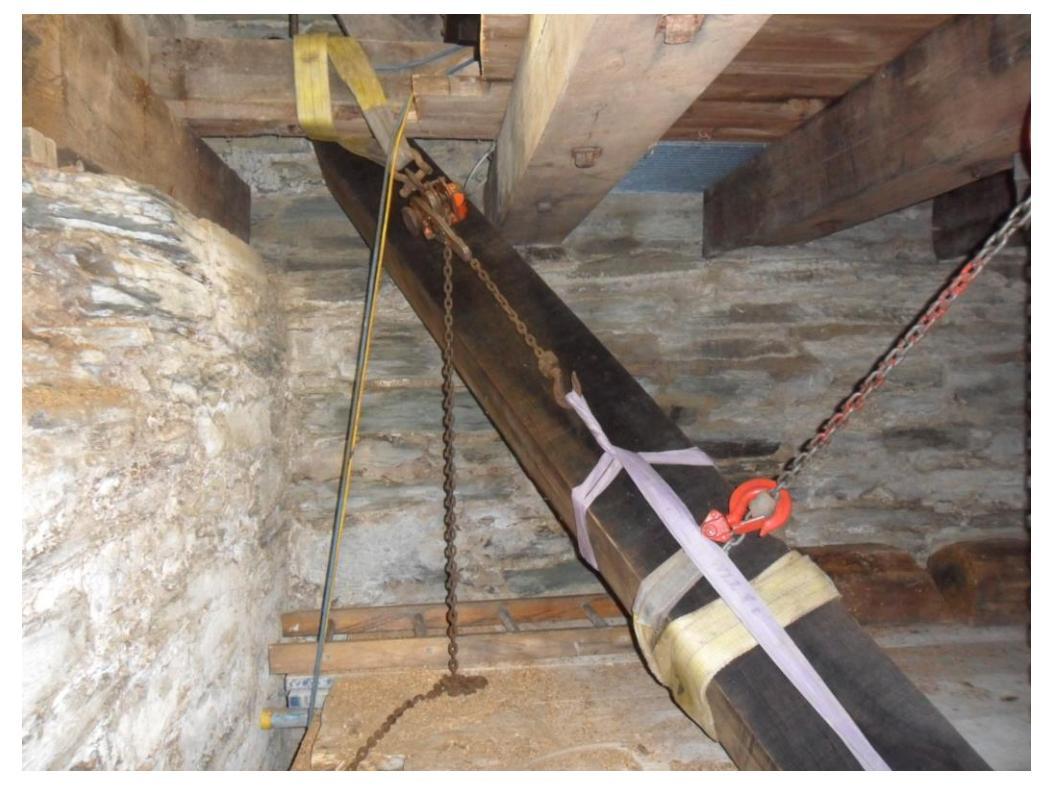
...TO THE UNDERSIDE OF THE OLD BELL CHAMBER FLOOR.
