PEARSON LUBBOCK ARCHITECTS
BELL CHAMBER OPENINGS BEFORE AND AFTER FIRST PHASE

ST WINNOW CHURCH TOWER FIRST PHASE

5TH OCTOBER 2016

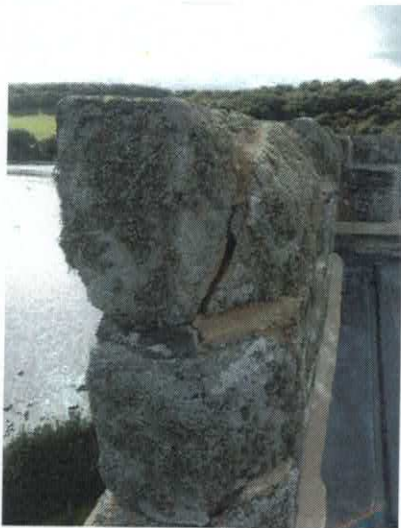
A MERLON CAPSTONE TO THE SOUTH PARAPET WALL OF THE TOWER ROOF (940X250X260MM) HAS CRACKED VERTICALLY DOWN ITS LENGTH.

IF RAINWATER GETS INTO THE CRACK AND FREEZES THE OUTER PIECE COULD FALL INTO THE CREMATED REMAINS AREA AT THE BASE OF THE SOUTH SIDE OF THE TOWER.

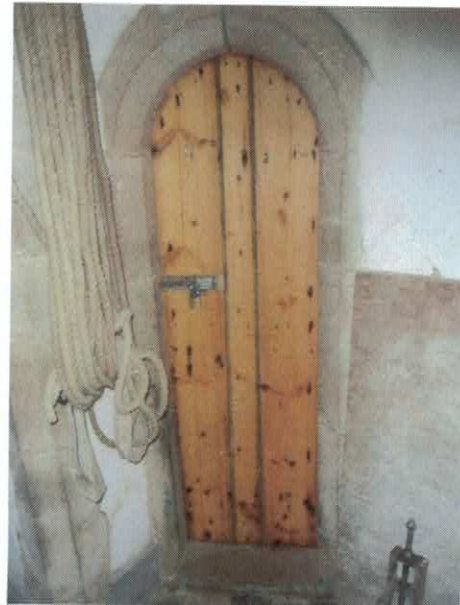
DOOR TO
TOWER STAIRS
OUTER LAYER
REMOVED,
ORIGINAL
DOOR
RESTORED AND
REHUNG
